Creating TSF Histories Using Modern Commercial and Declassified Cold War Satellite Photos

Gerry Mitchell,
Jim Turner, &
Sam Rivett

PhotoSat, Vancouver, BC, Canada

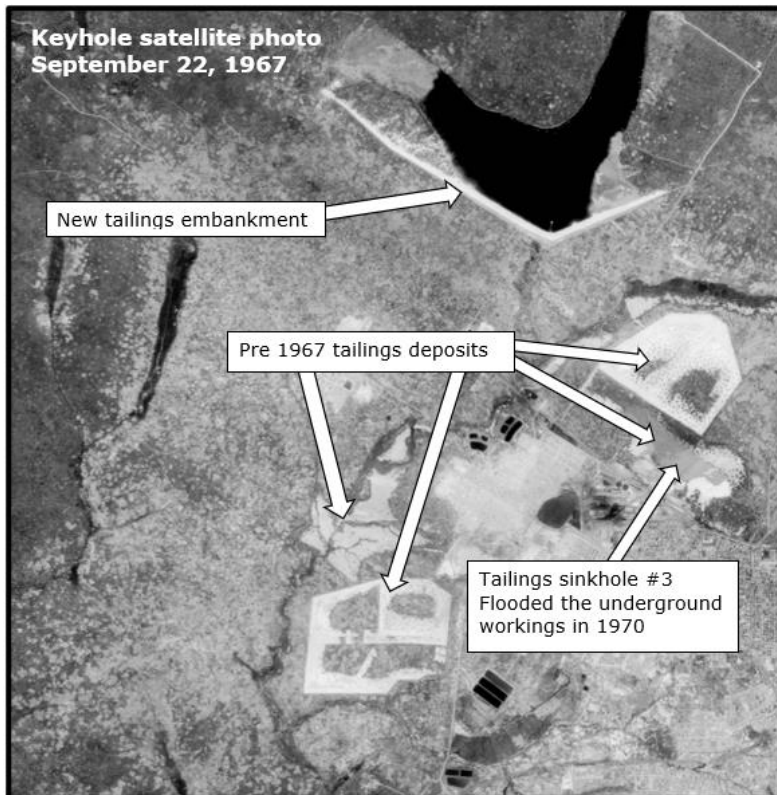
The record of archive cloud free satellite photos over the Mufulira mine site begins with a September 22, 1967 stereo pair of US Keyhole spy satellite photos (see Figure 1, which shows four of the mine tailings deposits used up until 1967, and the large tailings embankment and water dam to the north that appears to be new in 1967). The satellite record ends, as of the date of this report, with a March 23, 2020 stereo pair of 30 cm ground resolution Maxar WorldView-3 satellite photos.

Figure 1. Declassified US Keyhole spy satellite photo of the Mfulira mine site and tailings dams taken on September 22, 1967.

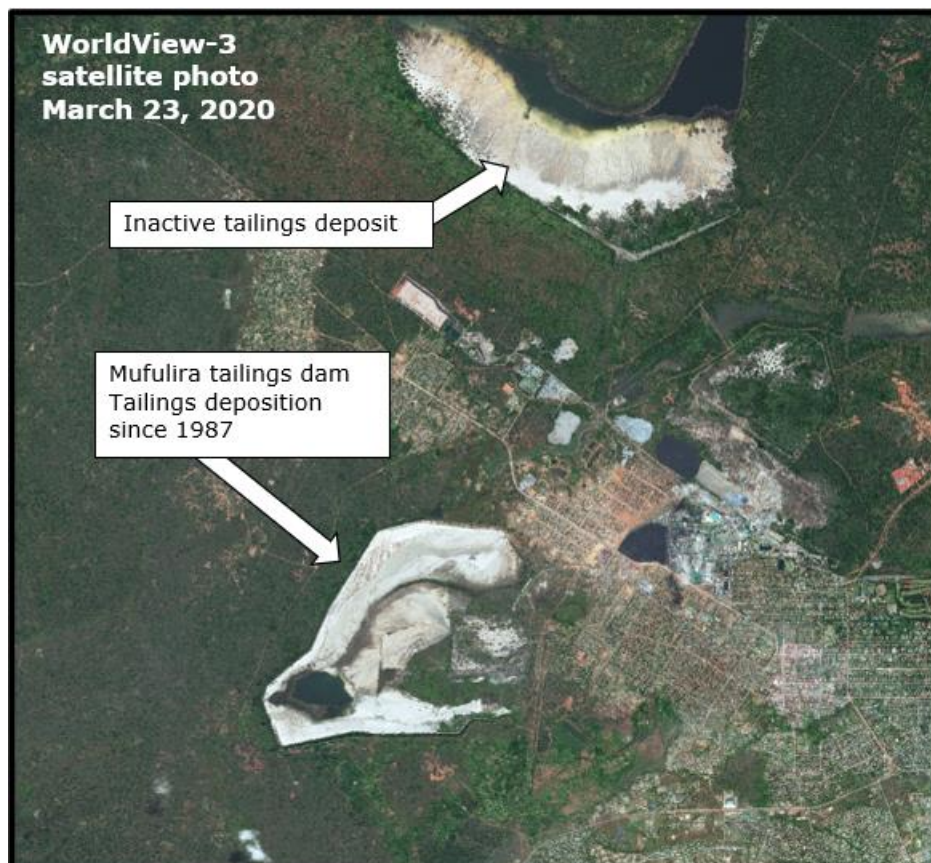
Figure 2. WorldView-3 satellite photo of the Mfulira mine site and tailings dam taken on March 23, 2020.

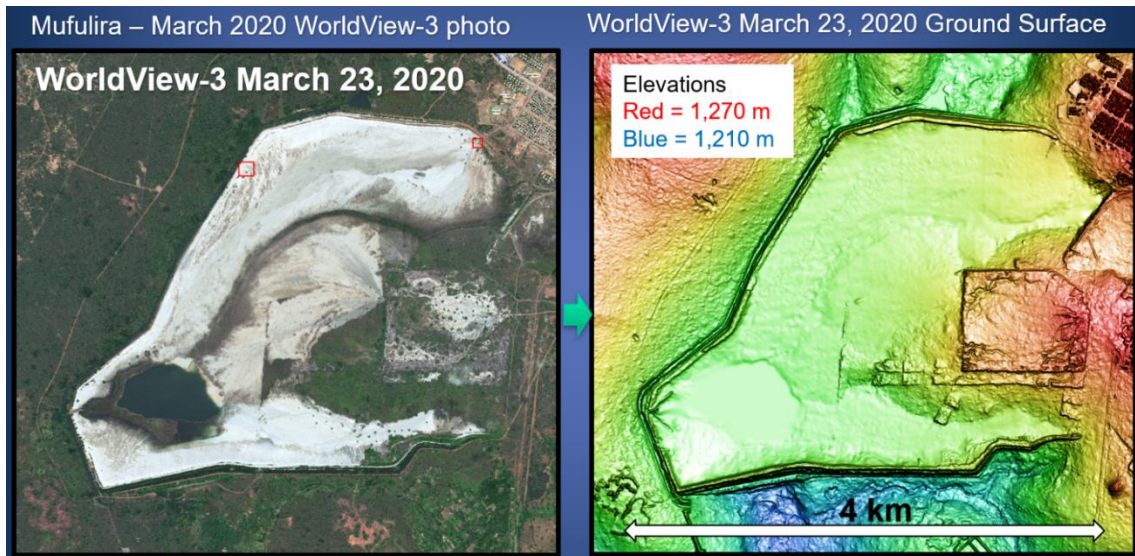
Figure 3. Elevation surface of the surface of the Mufulira tailings dam March 23, 2020 derived from WorldView-3 stereo satellite photos.

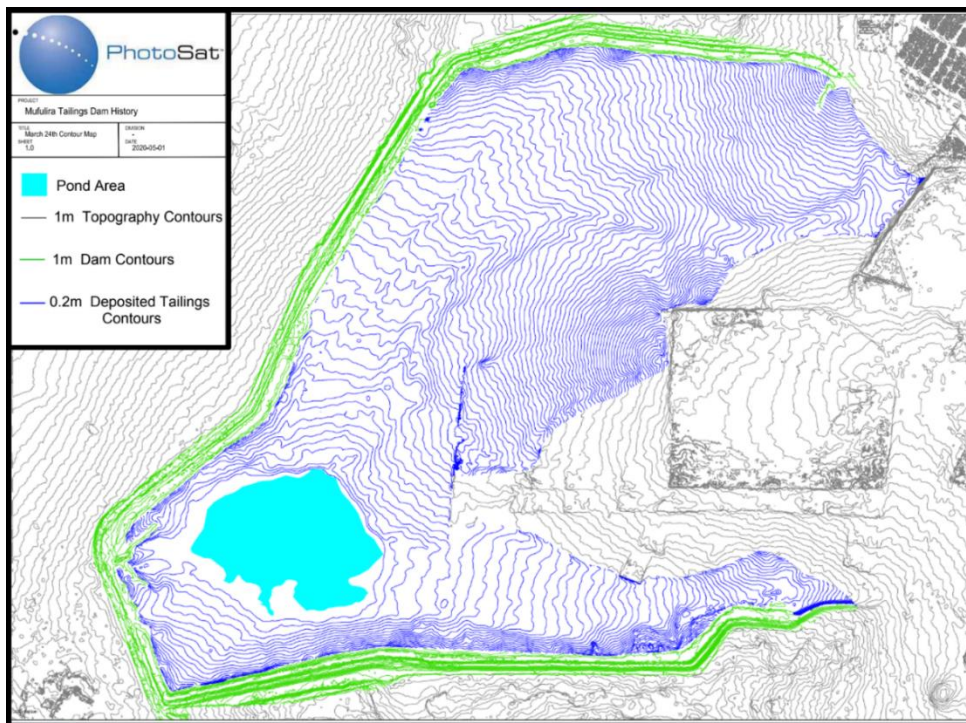
Figure 4. Elevation contours of the March 23, 2020 surface of the Mufulira tailings dam. Top of tailings 20 cm contours in blue. Surrounding area 1 m contours.

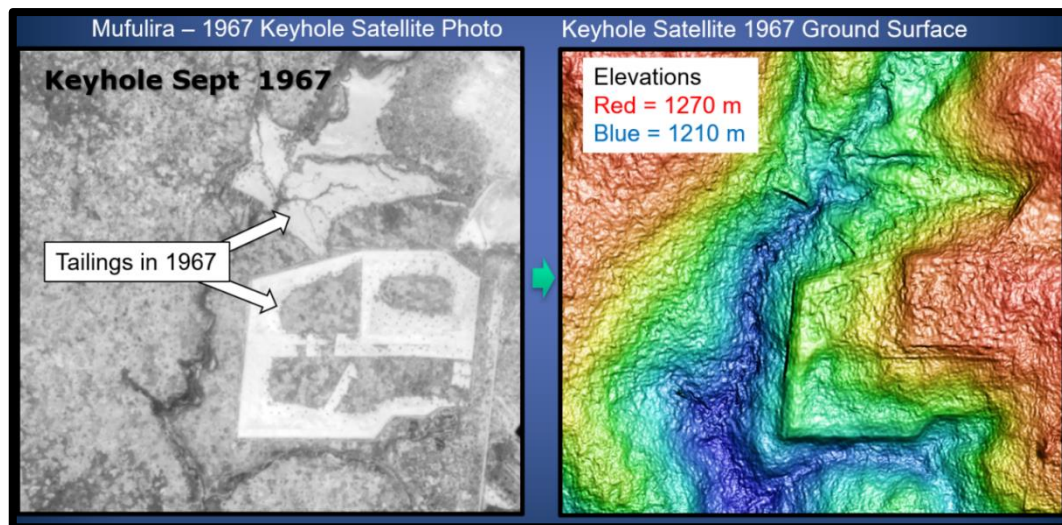
This 1967 topographic surface derived from the stereo Keyhole satellite photos has an estimated accuracy of one to two meters in elevation. The elevation grid of the base of the Mufulira tailings dam derived from the 1967 stereo Keyhole satellite photos is shown in Figure 5.

Figure 5. Elevation surface of the base of the Mufulira tailings dam derived from September 22, 1967 stereo Keyhole satellite photos.

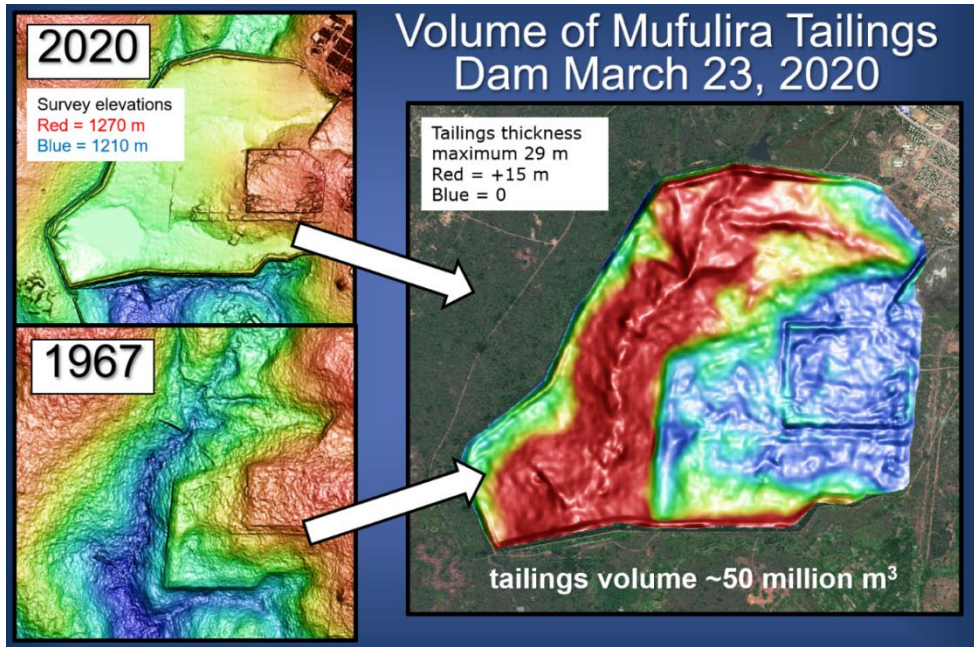
PhotoSat has measured the current thickness and volume of mine tailings and water in the Mufulira dam. The current volume of tailings and water in the dam is 50,000 m³. This measurement is made by comparing the 1967 topographic surface, of what is now the base of the Mufulira tailings dam, with the present topographic surface created from the March 23, 2020 WorldView-3 stereo satellite.

Figure 6. The tailings thickness and the volume of tailings and water in the Mufulira Tailings Dam on March 23, 2020. Maximum tailings thickness 29m.

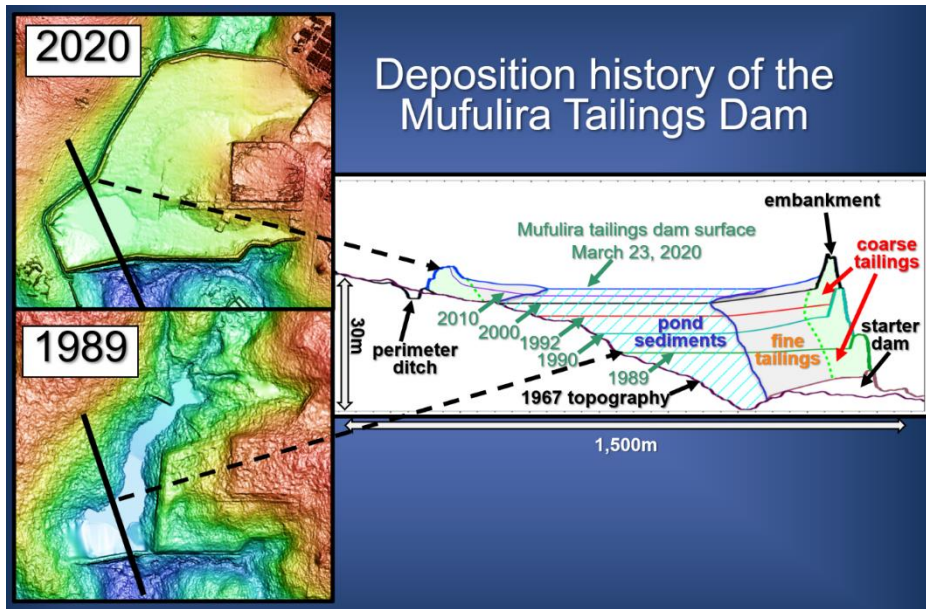
The stratigraphic cross section of the Mufulira tailings dam shown in Figure 7 was created using the PhotoSat WorldView 2010, 2017 and 2020 surveys and the nearly 300 satellite photos taken between 1987 and 2020. The probable distribution of coarse sands, fine sands and tailings deposited beneath the pond is shown in the cross section.

Figure 7. The Mufulira tailings dam topographic surfaces for March 23, 2020 and August 21, 1989. Cross section showing the tailings dam topographic surfaces for different years.
