AbraPlata Diablillos Case History

Drill Hole Collar Verification
through a Comparison of
Survey Data Sets

Revised: January 7th, 2021

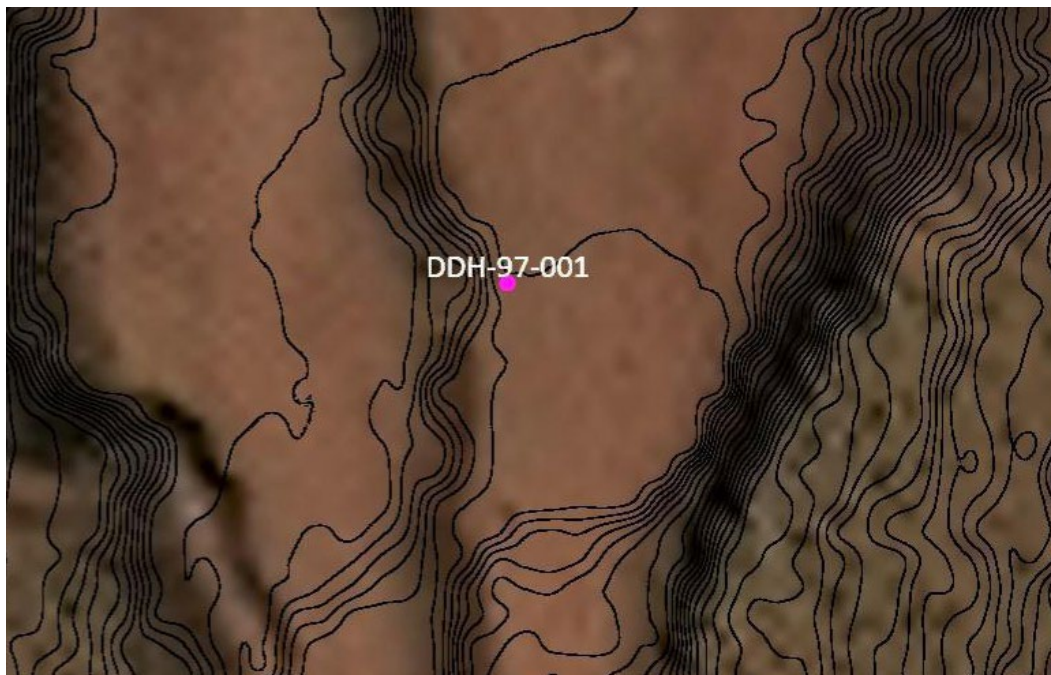
Figure 9: Location of drill hole collar DDH-97-001

| Point ID | Difference from PhotoSat elevation survey (cm) | Remarks |
|---|--|---|
| DDH-97-001 | -108 | probable vertical drill hole collar survey error |

DDH-97-001

This drill hole collar has a probable vertical survey error.

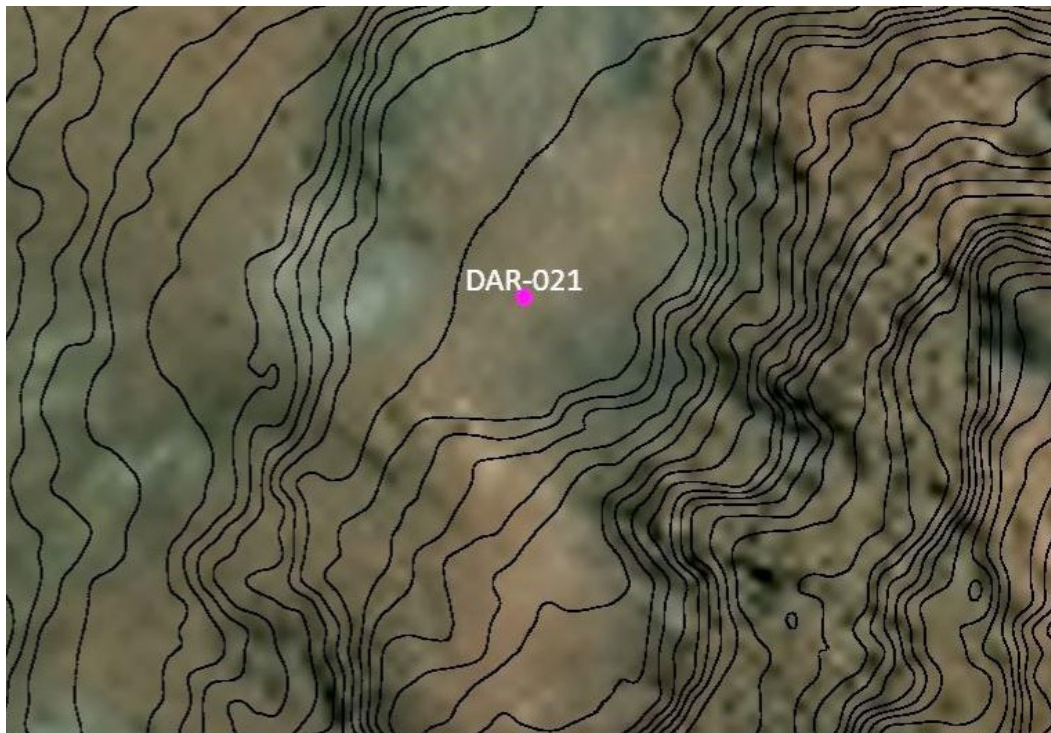
Figure 10: Location of drill hole collar DAR-021

| Point ID | Difference from PhotoSat elevation survey (cm) | Remarks |
|---|--|---|
| DAR-021 | -65 | probable vertical drill hole collar survey error |

DAR-021

This drill hole collar has a probable vertical survey error.

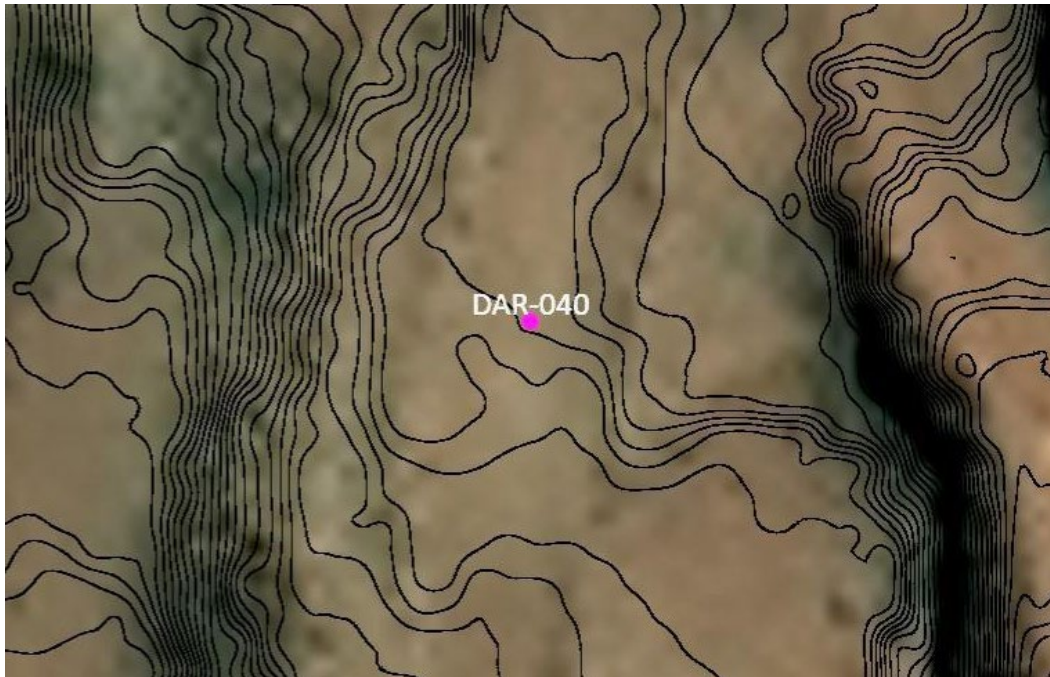
Figure 11: Location of drill hole collar DAR-040

| Point ID | Difference from PhotoSat elevation survey (cm) | Remarks |
|---|--|---|
| DAR-040 | -69 | possible drill hole collar survey error, possible road building |

DAR-040

This drill hole collar has a possible survey error or possibly the surface has been changed by road works.

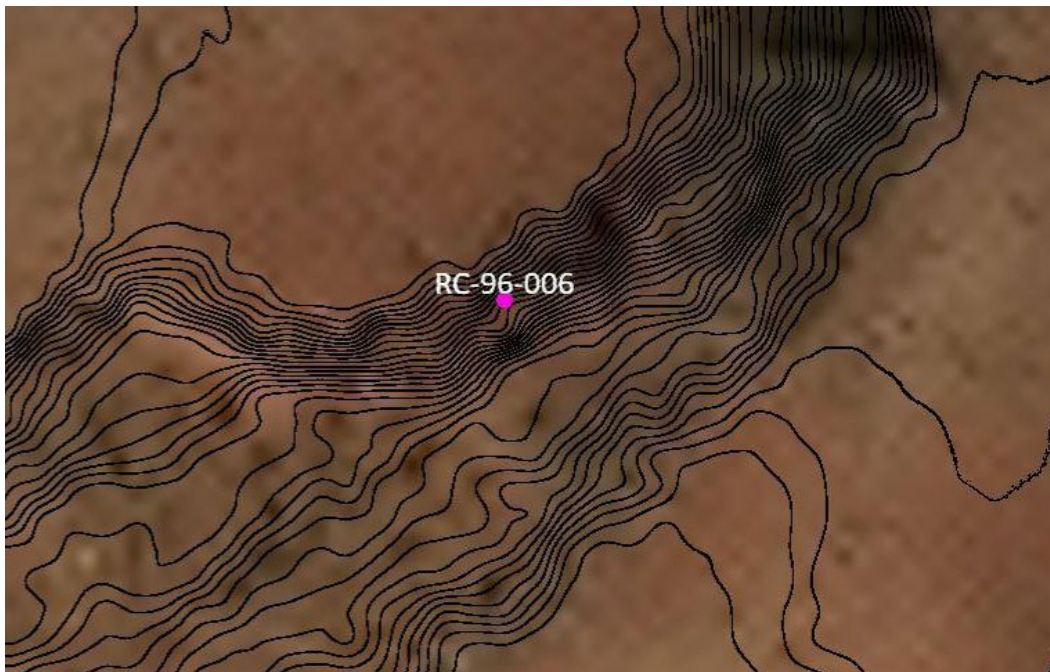
Figure 12: Location of drill hole collar RC-96-006

| Point ID | Difference from PhotoSat elevation survey (cm) | Remarks |
|---|--|---|
| RC-96-006 | -169 | probable horizontal drill hole collar survey error |

RC-96-006

This drill hole collar has a probable horizontal survey error as it would not have been located on a slope.

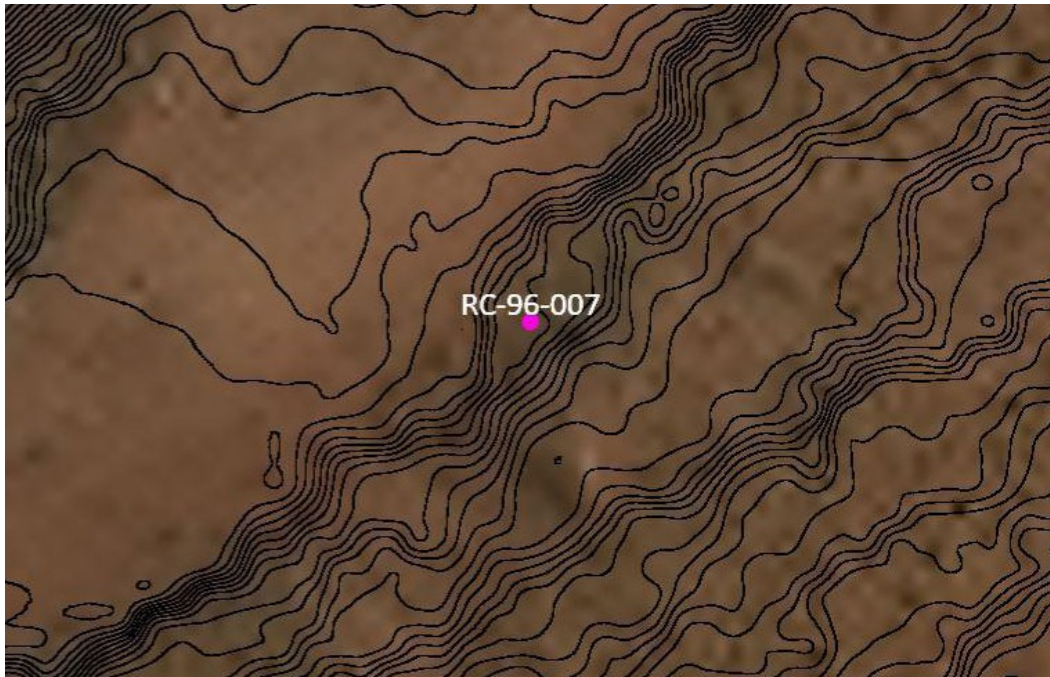
Figure 13: Location of drill hole collar RC-96-007

| Point ID | Difference from PhotoSat elevation survey (cm) | Remarks |
|---|--|---|
| RC-96-007 | -76 | probable horizontal drill hole collar survey error |

RC-96-007

This drill hole collar has a probable horizontal survey error as it would not have been located on a slope.

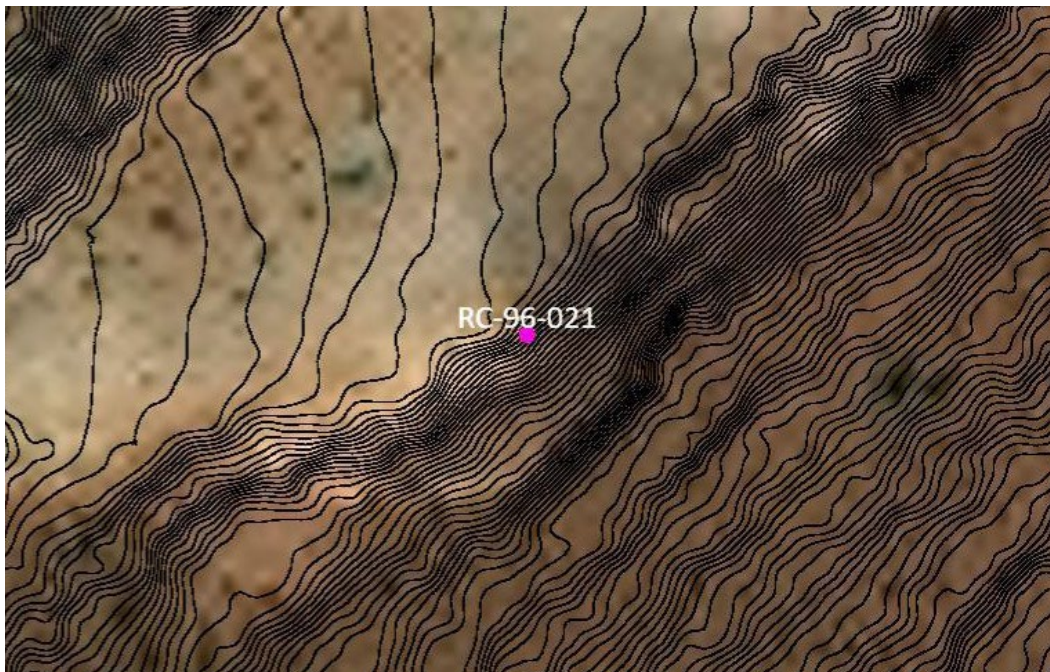
Figure 14: Location of drill hole collar RC-96-021

| Point ID | Difference from PhotoSat elevation survey (cm) | Remarks |
|---|--|---|
| RC-96-021 | -69 | probable vertical / horizontal drill hole collar survey error |

RC-96-021

This drill hole collar has a probable vertical / horizontal survey error as it would not have been located on a slope.

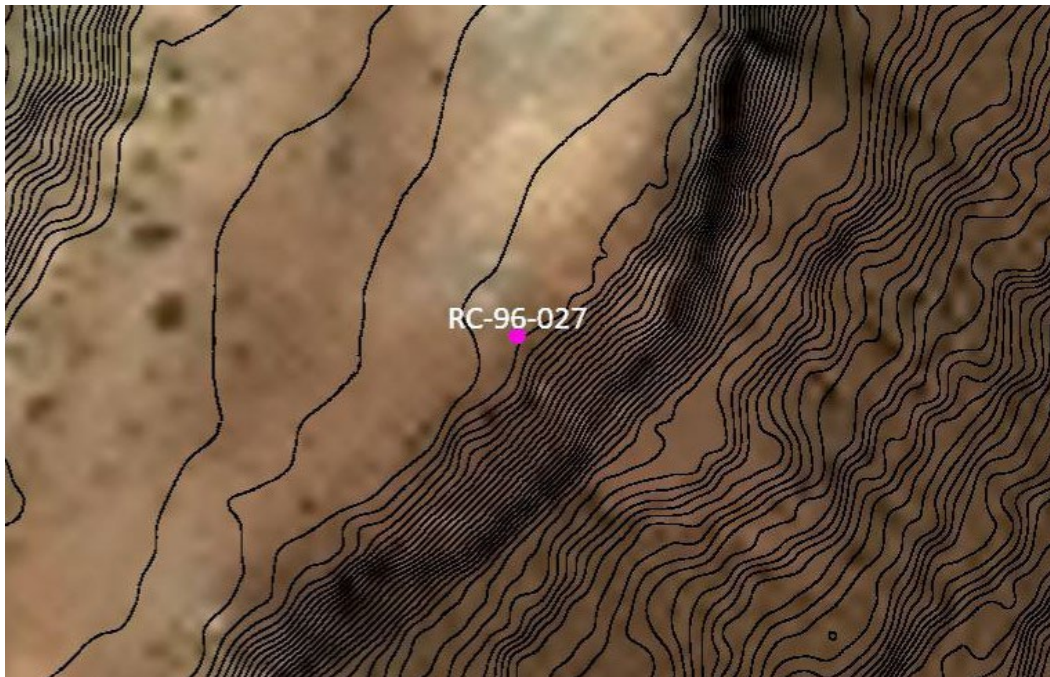
Figure 15: Location of drill hole collar RC-96-027

| Point ID | Difference from PhotoSat elevation survey (cm) | Remarks |
|---|--|---|
| RC-96-027 | 88 | probable vertical / horizontal drill hole collar survey error |

RC-96-027

This drill hole collar has a probable vertical / horizontal survey error.

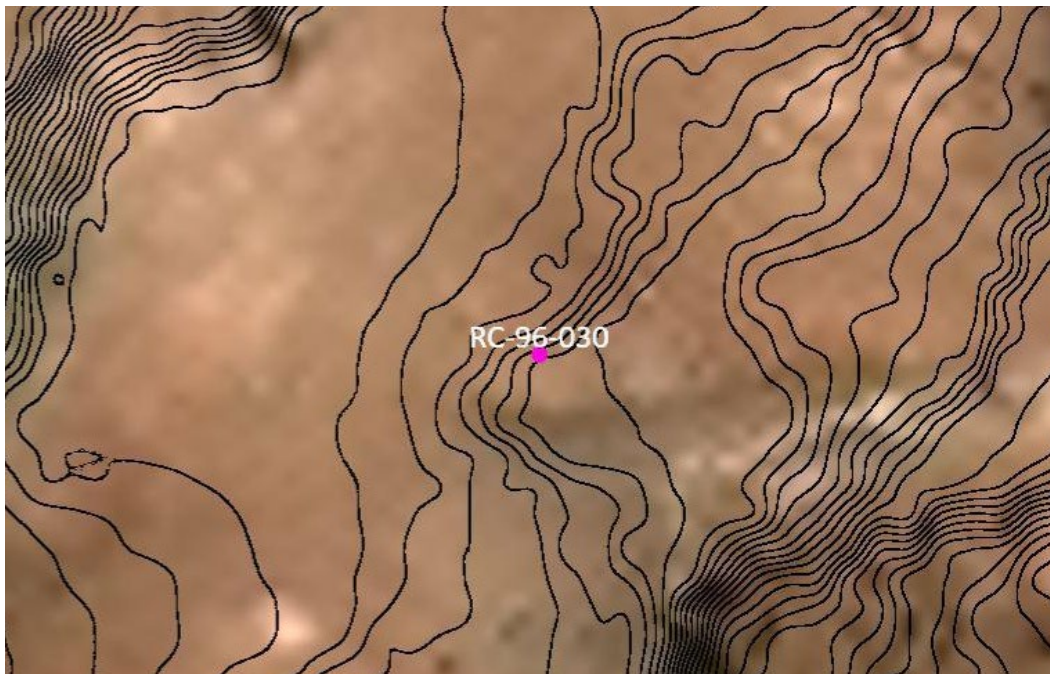
Figure 16: Location of drill hole collar RC-96-030

| Point ID | Difference from PhotoSat elevation survey (cm) | Remarks |
|---|--|---|
| RC-96-030 | -110 | probable horizontal drill hole collar survey error |

RC-96-030

This drill hole collar has a probable horizontal survey error.

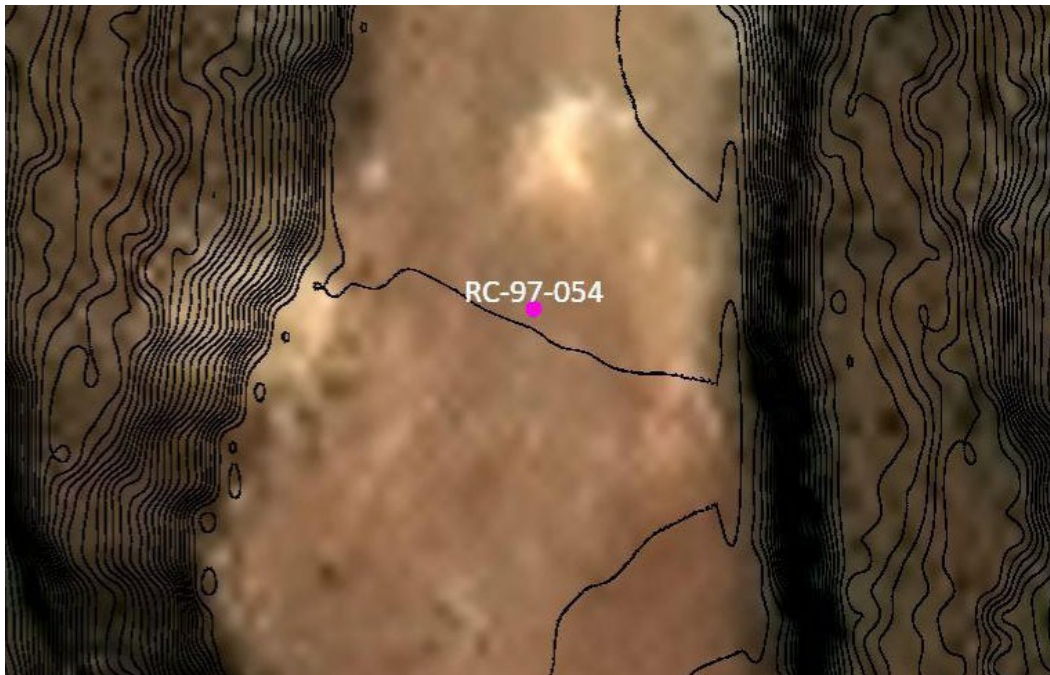
Figure 17: Location of drill hole collar RC-97-054

| Point ID | Difference from PhotoSat elevation survey (cm) | Remarks |
|---|--|---|
| RC-97-054 | 63 | probable vertical drill hole collar survey error |

RC-97-054

This drill hole collar has a probable vertical survey error.

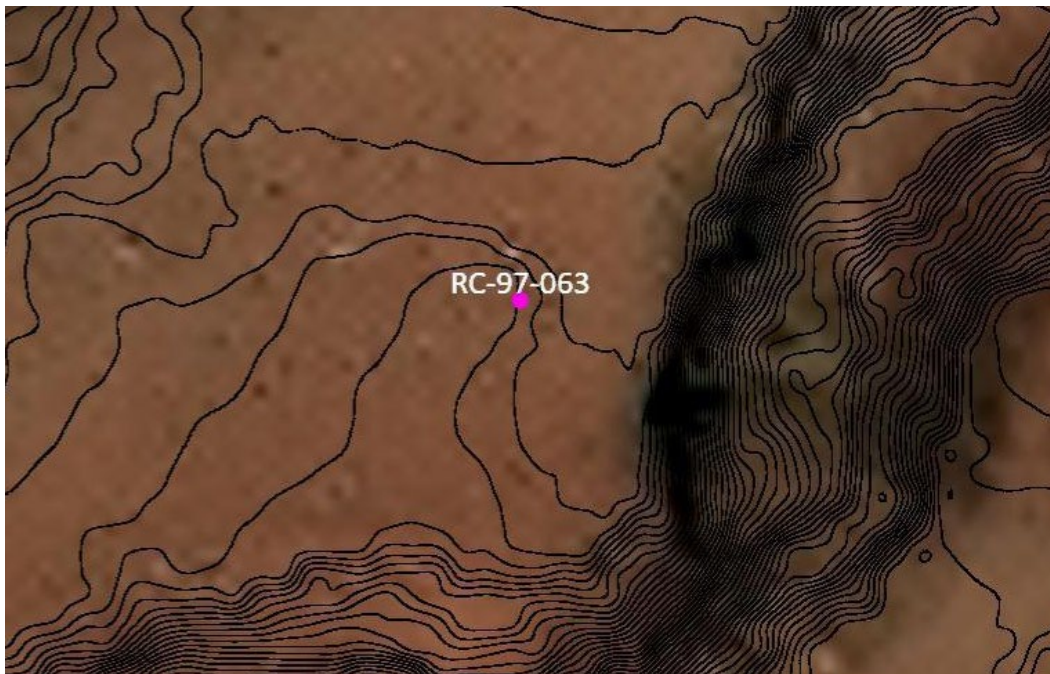
Figure 18: Location of drill hole collar RC-97-063

| Point ID | Difference from PhotoSat elevation survey (cm) | Remarks |
|---|--|---|
| RC-97-063 | -98 | probable vertical / horizontal drill hole collar survey error |

RC-97-063

This drill hole collar has a probable vertical / horizontal survey error.

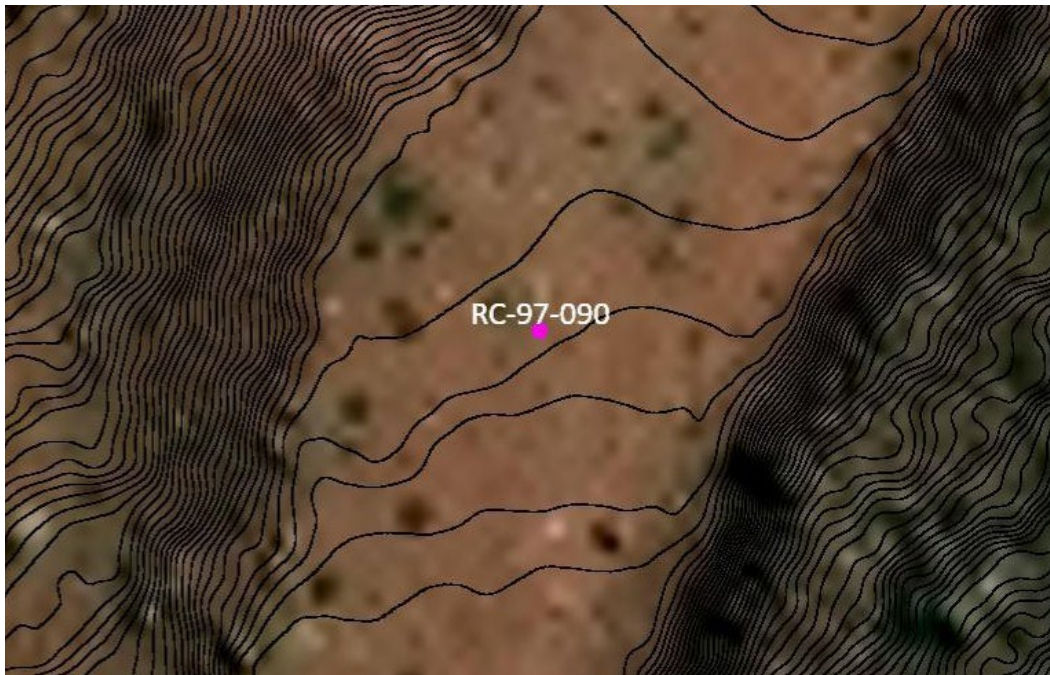
Figure 19: Location of drill hole collar RC-97-090

| Point ID | Difference from PhotoSat elevation survey (cm) | Remarks |
|---|--|---|
| RC-97-090 | 86 | probable vertical drill hole collar survey error |

RC-97-090

This drill hole collar has a probable vertical survey error.
