# PhotoSat surveying case history: AbraPlata Diablillos project in Argentina

by **Gerry Mitchell, P. Geo, PhotoSat President**  
*Vancouver, 2019*

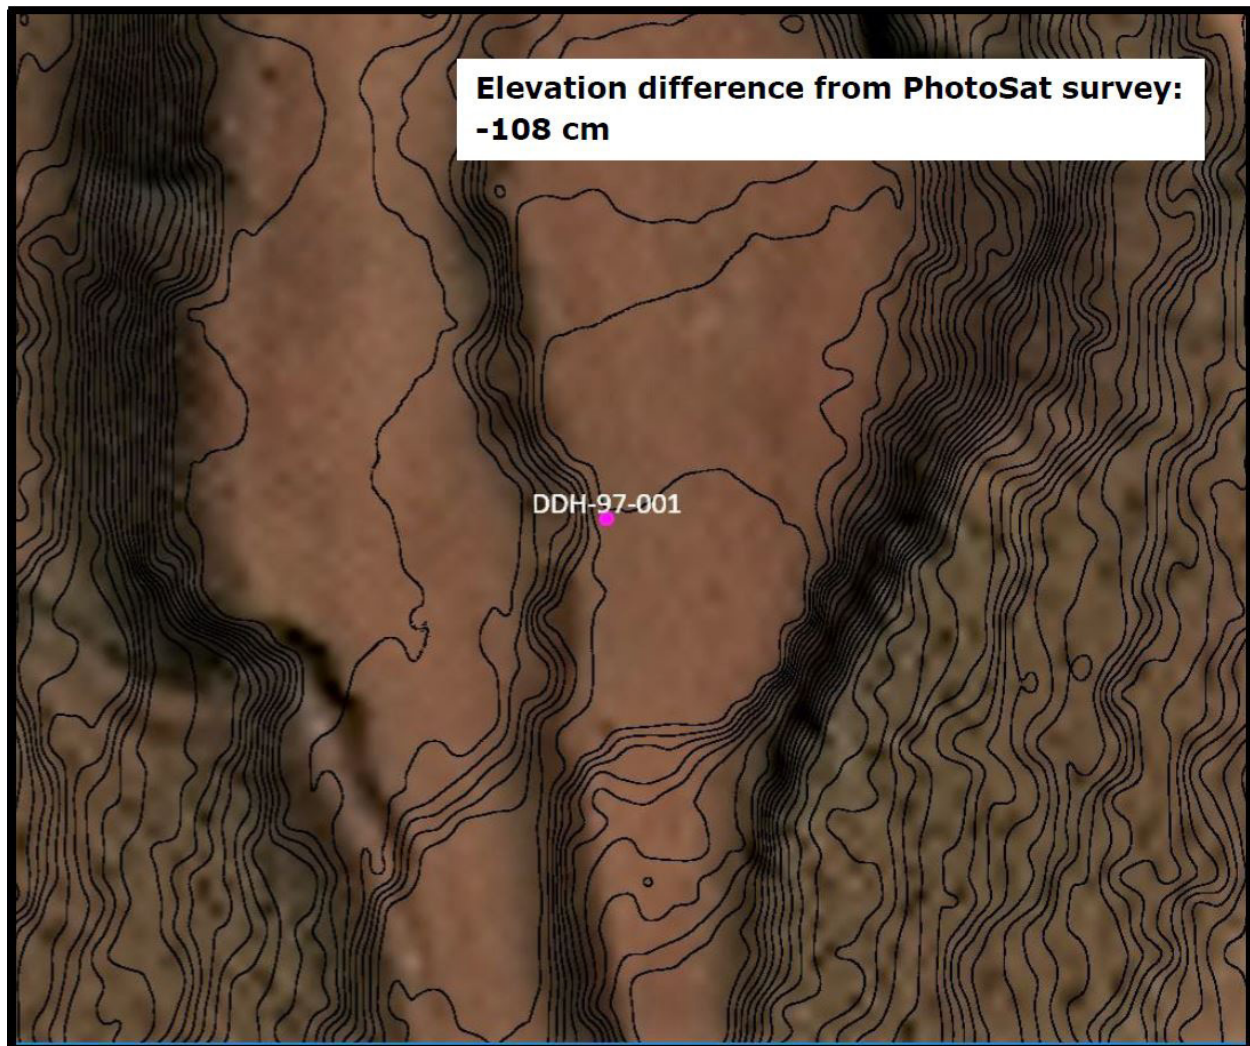
*Figure 8. Drill hole collar DDH-97-001 overlaid on the orthophoto, displayed with 20cm contours. This drill hole collar has a probable vertical survey error.*

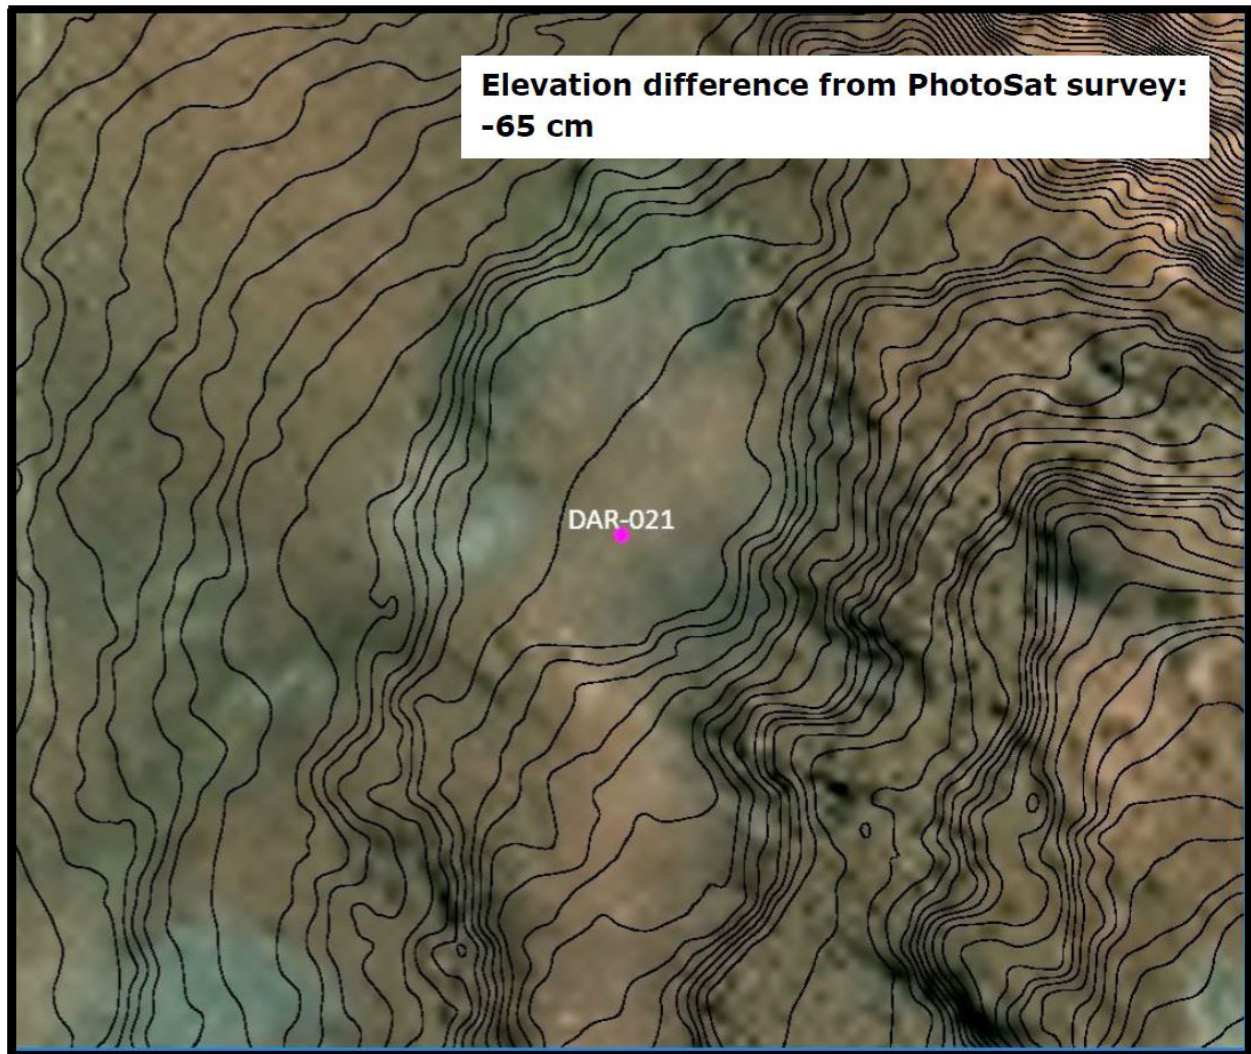
*Figure 9. Drill hole collar DAR-021 overlaid on the orthophoto, displayed with 20cm contours. This drill hole collar has a probable vertical survey error.*

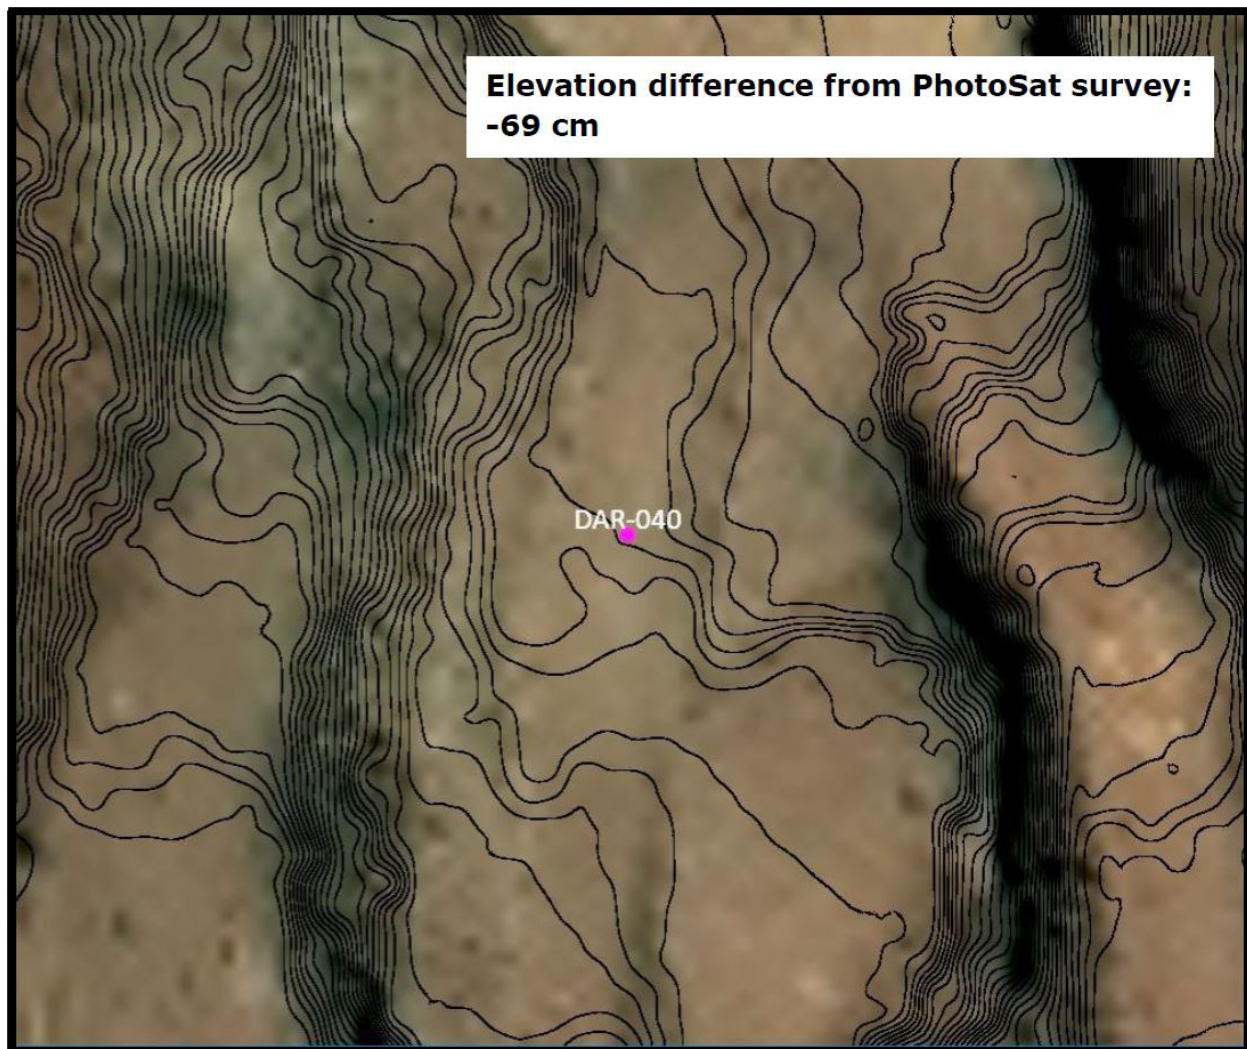
*Figure 10. Drill hole collar DAR-040 overlaid on the orthophoto, displayed with 20cm contours. This drill hole collar has a possible survey error or possibly the surface has been changed by road works.*

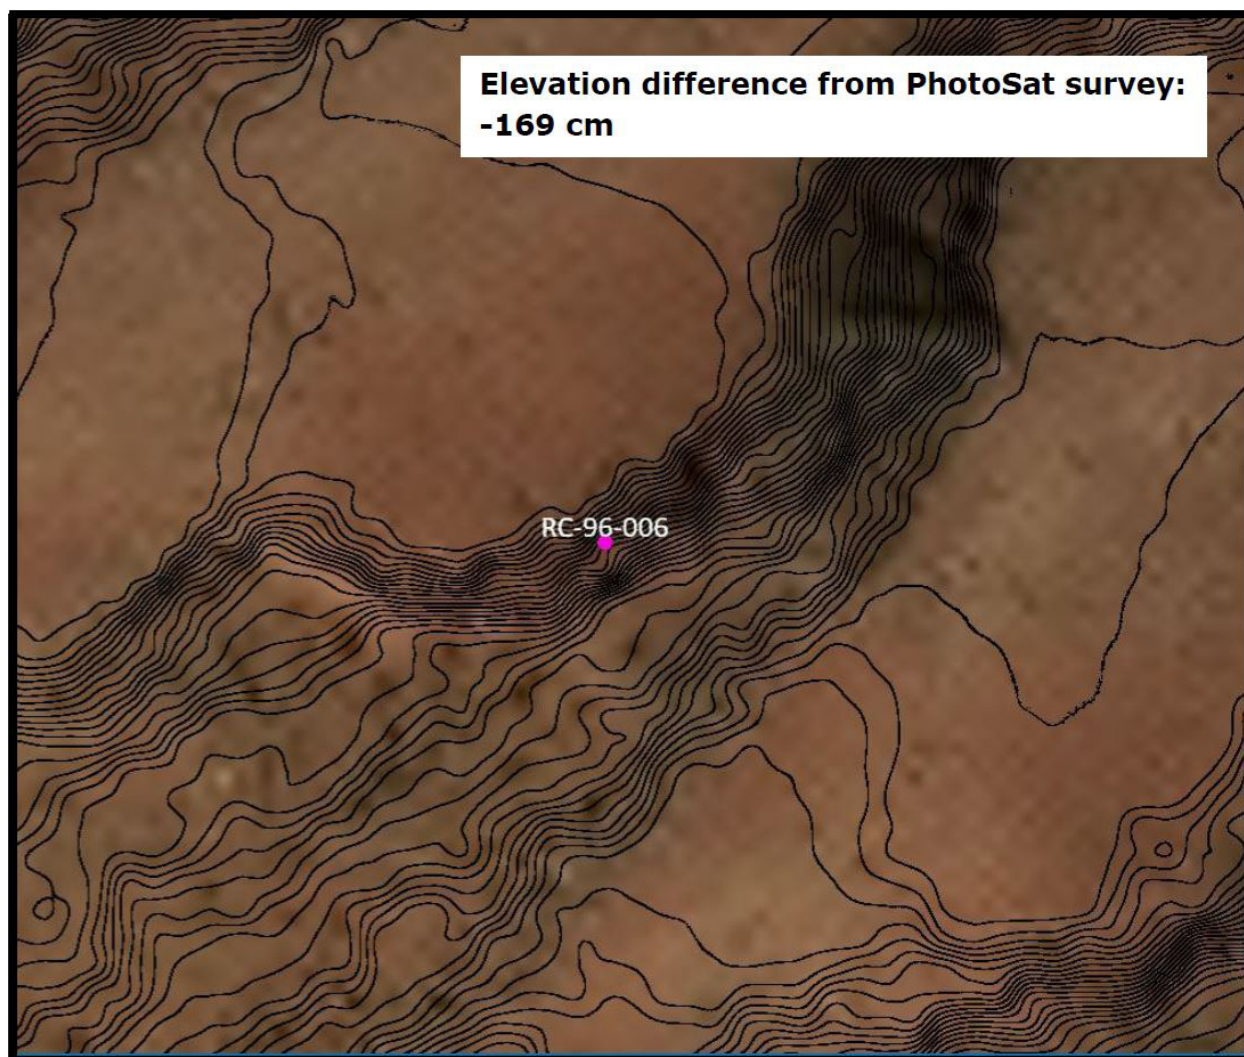
*Figure 11. Drill hole collar RC-96-006 overlaid on the orthophoto, displayed with 20cm contours. This drill hole collar has a probable horizontal survey error as it would not have been located on a slope.*

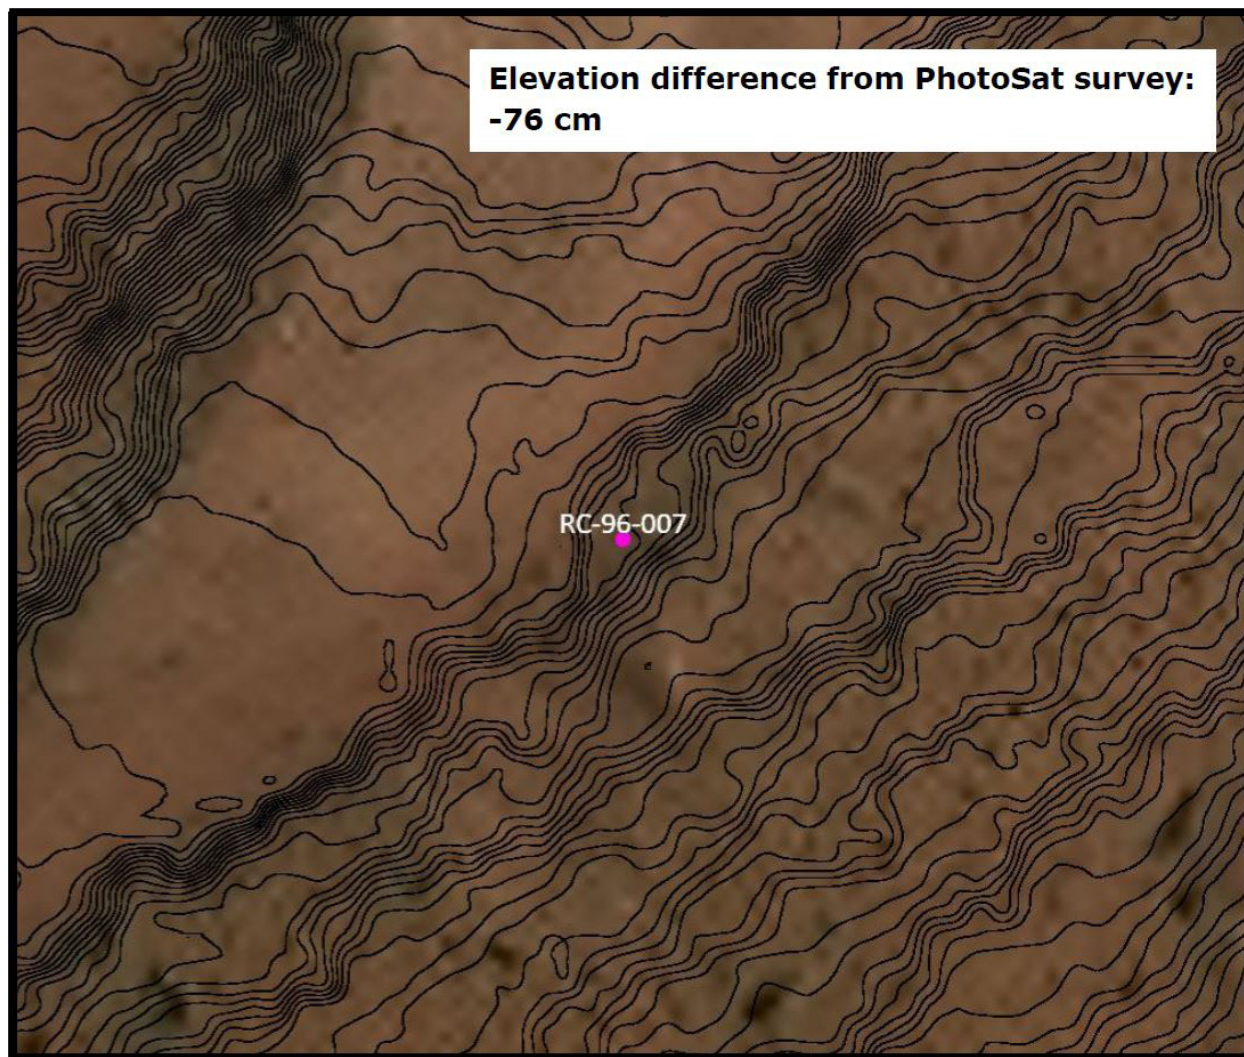
*Figure 12. Drill hole collar RC-96-007 overlaid on the orthophoto, displayed with 20cm contours. This drill hole collar has a probable horizontal survey error as it would not have been located on a slope.*

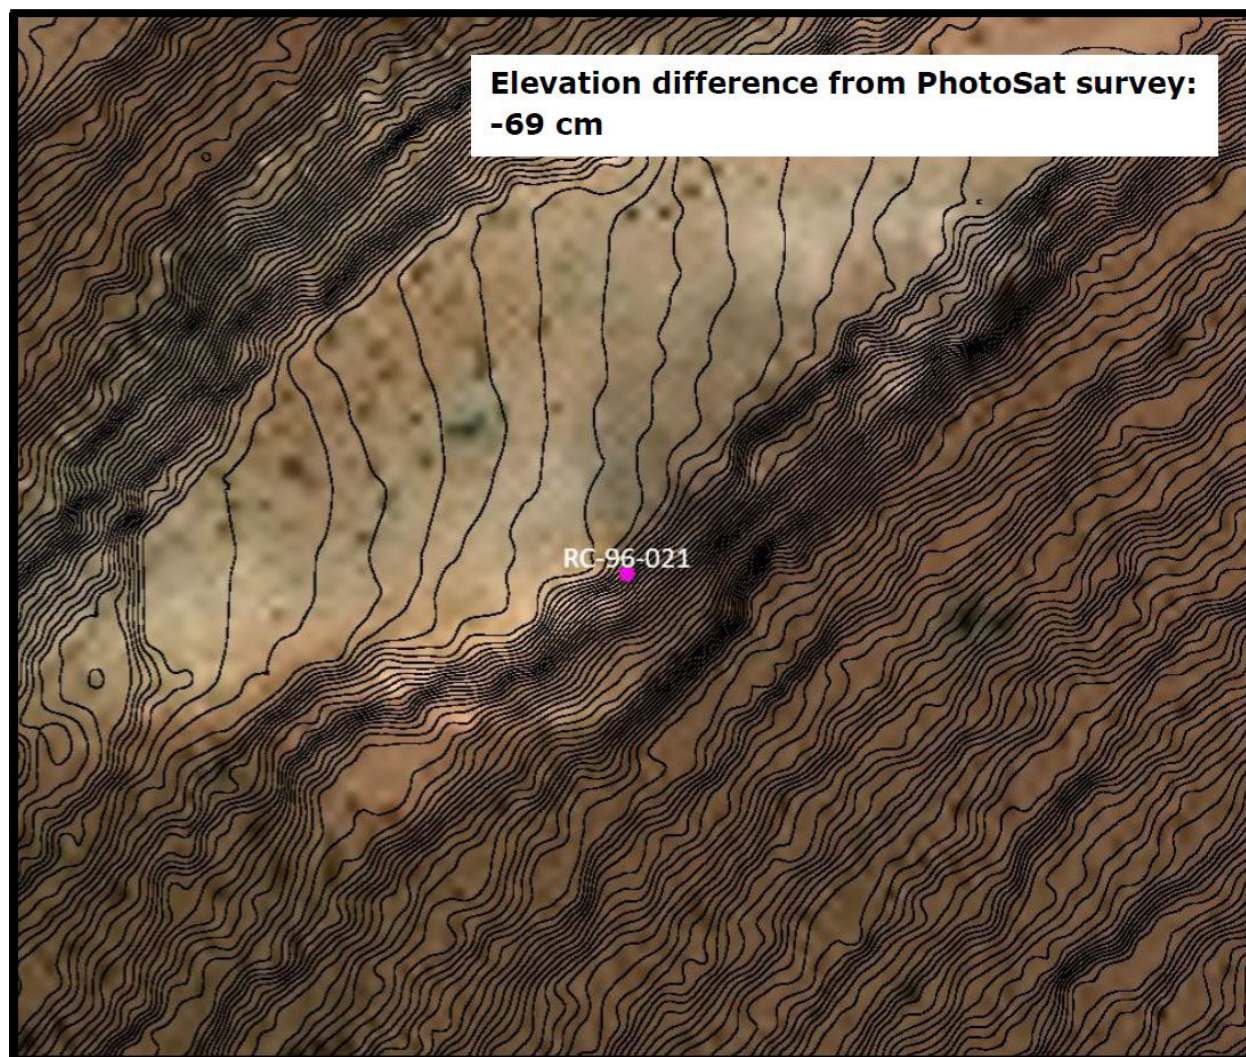
*Figure 13. Drill hole collar RC-96-021 overlaid on the orthophoto, displayed with 20cm contours. This drill hole collar has a probable vertical / horizontal survey error as it would not have been located on a slope.*

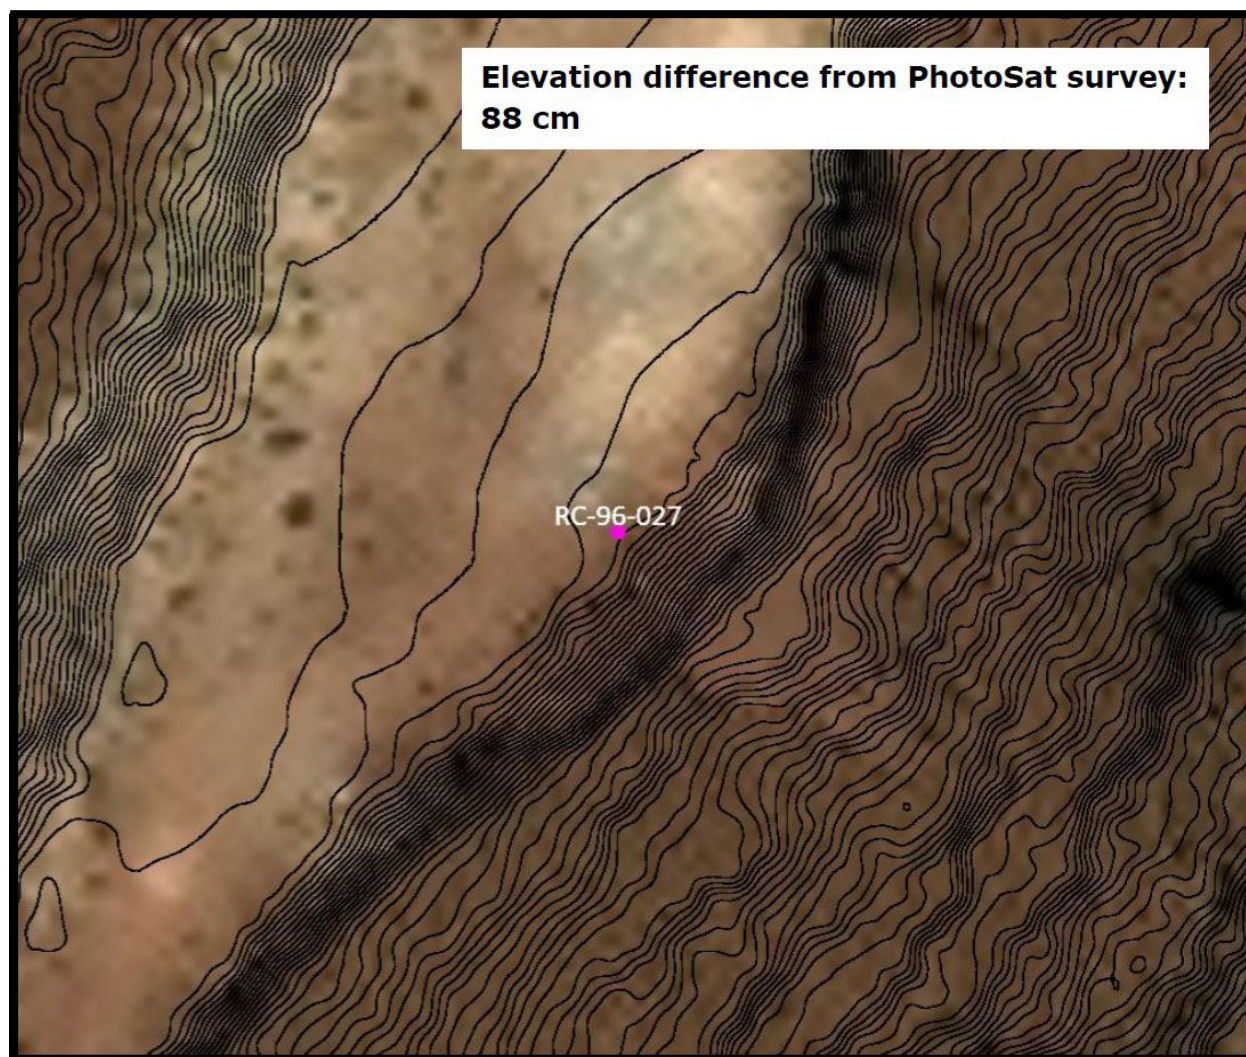
*Figure 14. Drill hole collar RC-96-027 overlaid on the orthophoto, displayed with 20cm contours. This drill hole collar has a probable vertical / horizontal survey error.*

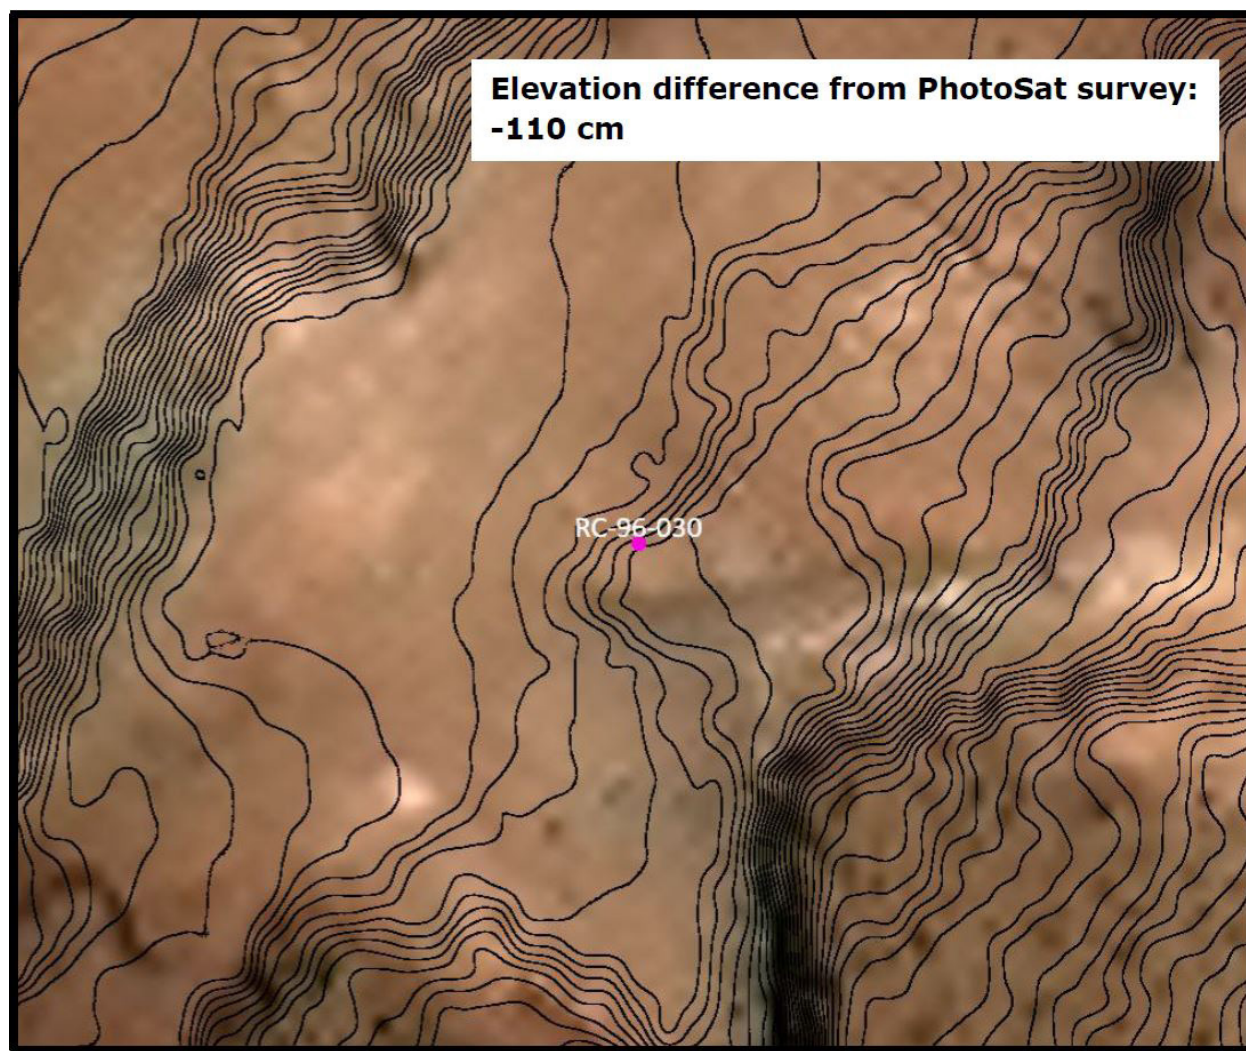
*Figure 15. Drill hole collar RC-96-030 overlaid on the orthophoto, displayed with 20cm contours. This drill hole collar has a probable horizontal survey error.*

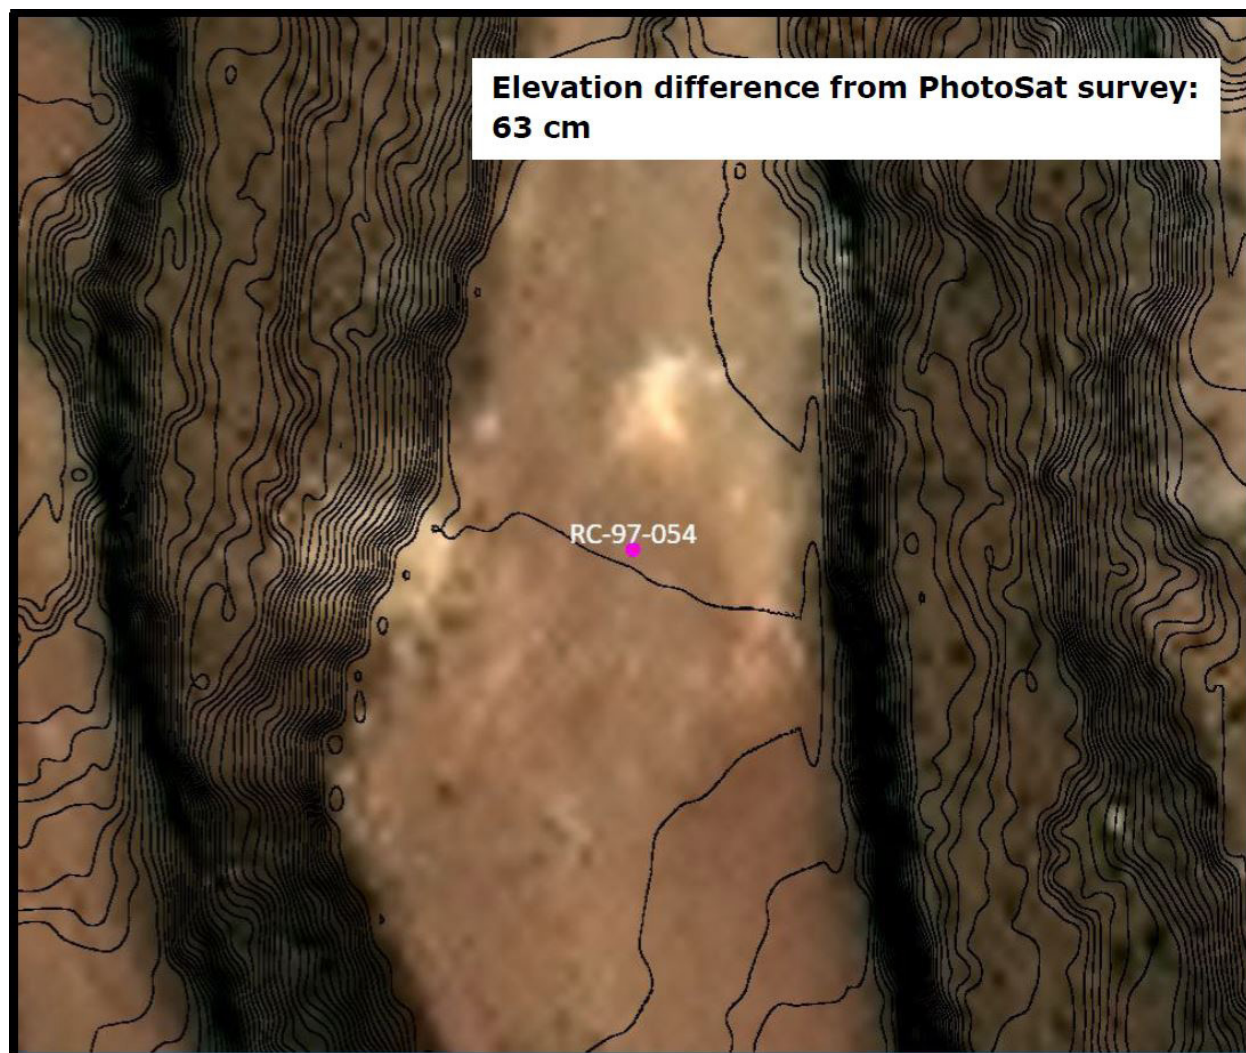
*Figure 16. Drill hole collar RC-97-054 overlaid on the orthophoto, displayed with 20cm contours. This drill hole collar has a probable vertical survey error.*

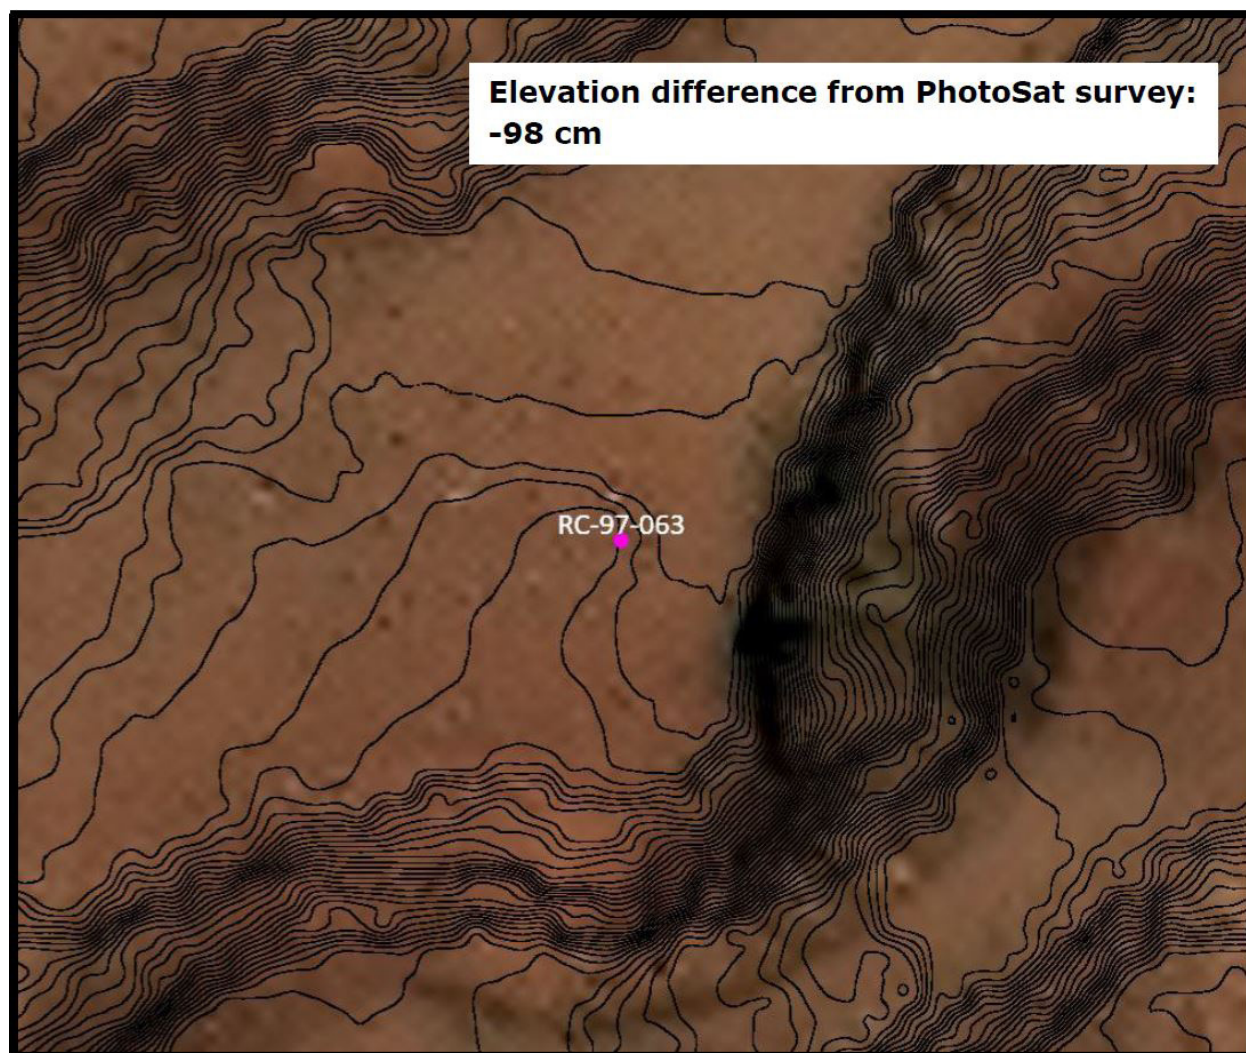
*Figure 17. Drill hole collar RC-97-063 overlaid on the orthophoto, displayed with 20cm contours. This drill hole collar has a probable vertical / horizontal survey error.*

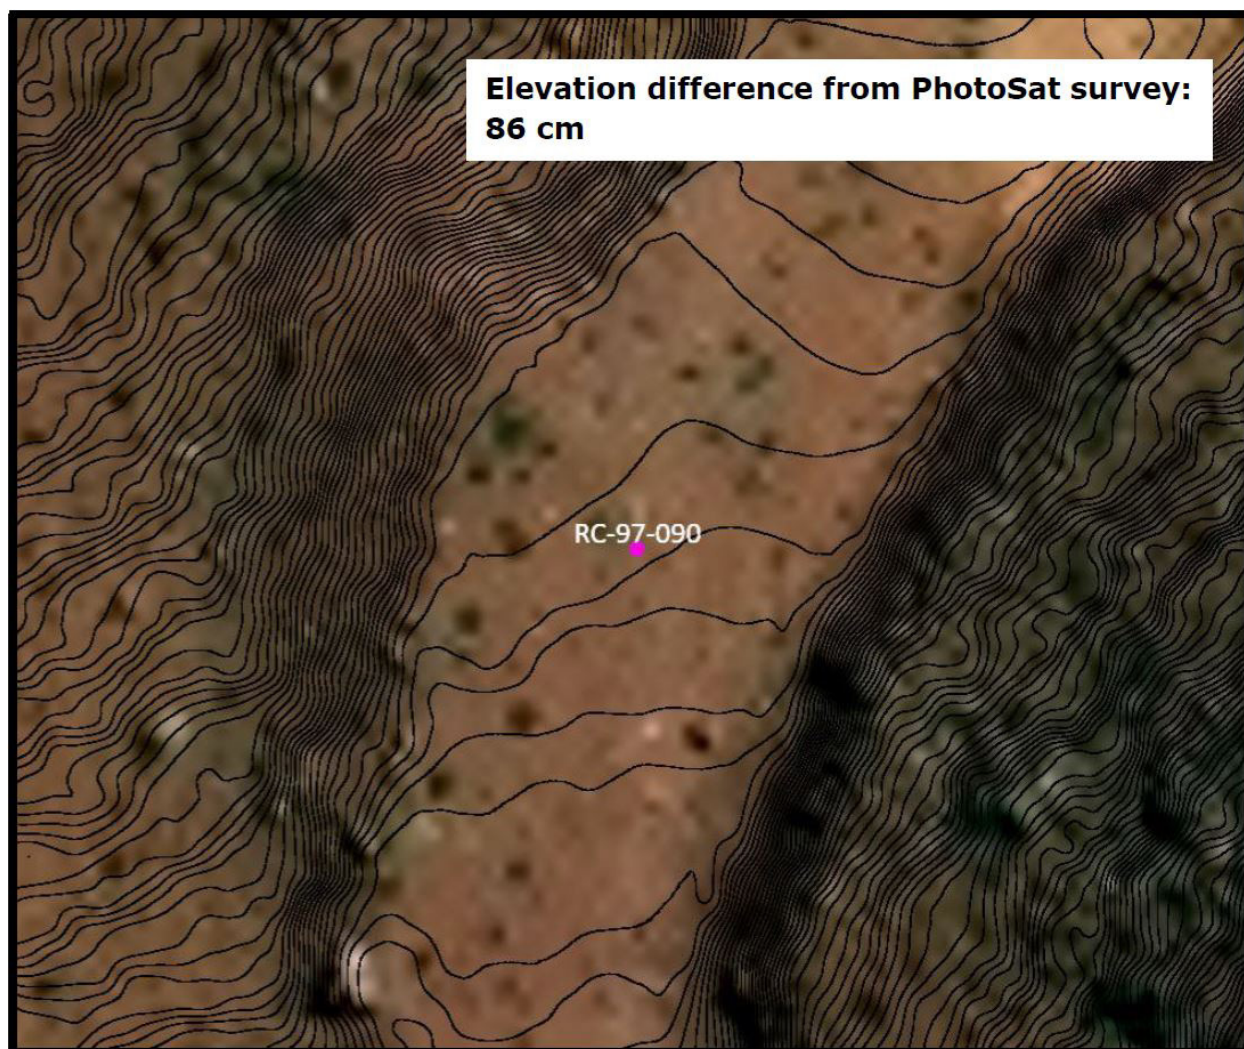
*Figure 18. Drill hole collar RC-97-090 overlaid on the orthophoto, displayed with 20cm contours. This drill hole collar has a probable vertical survey error.*
