GARLOCK FAULT | 10 GCP

# Accuracy Study

A Direct Comparison of  
Survey Data Produced  
from WorldView-3 Satellite  
Imagery with LiDAR

Published: February 8, 2021

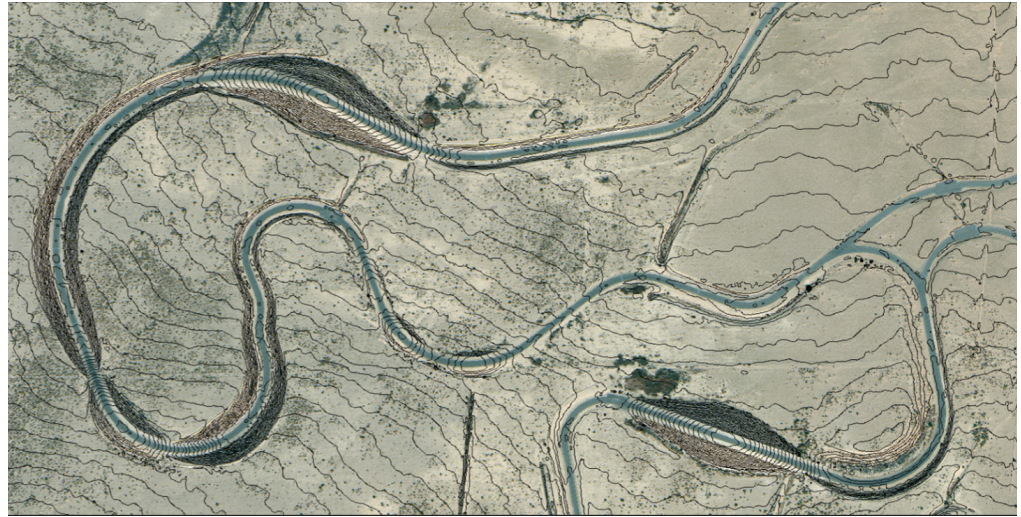
**Figure 2: Portion of the Garlock Fault test area**

Source [Fig 2]:

PhotoSat (2021)  
colour orthophoto  
with overlaid 50 cm  
contours

The Garlock Fault test area (Fig 2) is located approximately 200 km north of Los Angeles, CA.

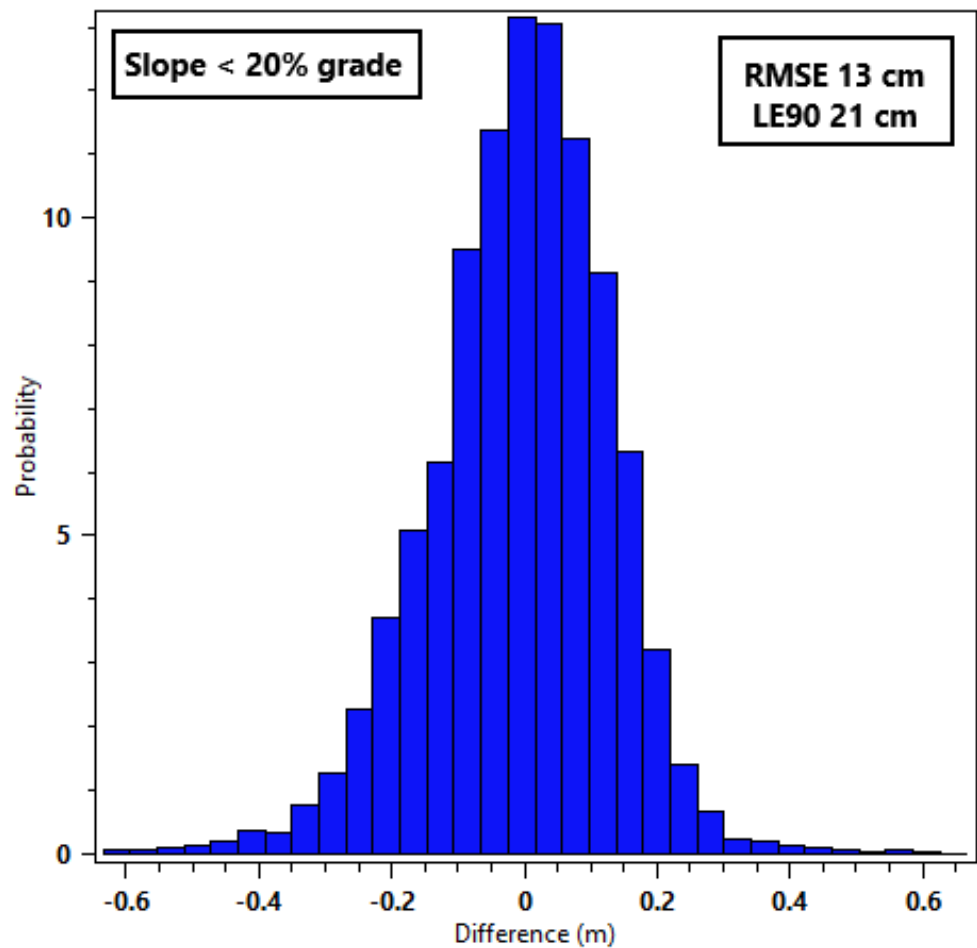
After the adjustments were completed, the accuracy of the PhotoSat survey was evaluated by direct comparison to the LiDAR survey.

The results are shown in a histogram (Fig 5).

Figure 5: Elevation differences between the PhotoSat survey and the LiDAR survey

Source [Fig 5]:  
PhotoSat (2021)  
histogram  
of elevation  
differences

13 cm RMSE; LE90 21 cm
