Mufulira Case Study

Producing a Record of Construction
and Deposition from Archive
Satellite Imagery

In this case study, PhotoSat uses archive satellite imagery to produce a full historical record of construction and deposition for a tailings storage facility (TSF) at the Mopani Mine.

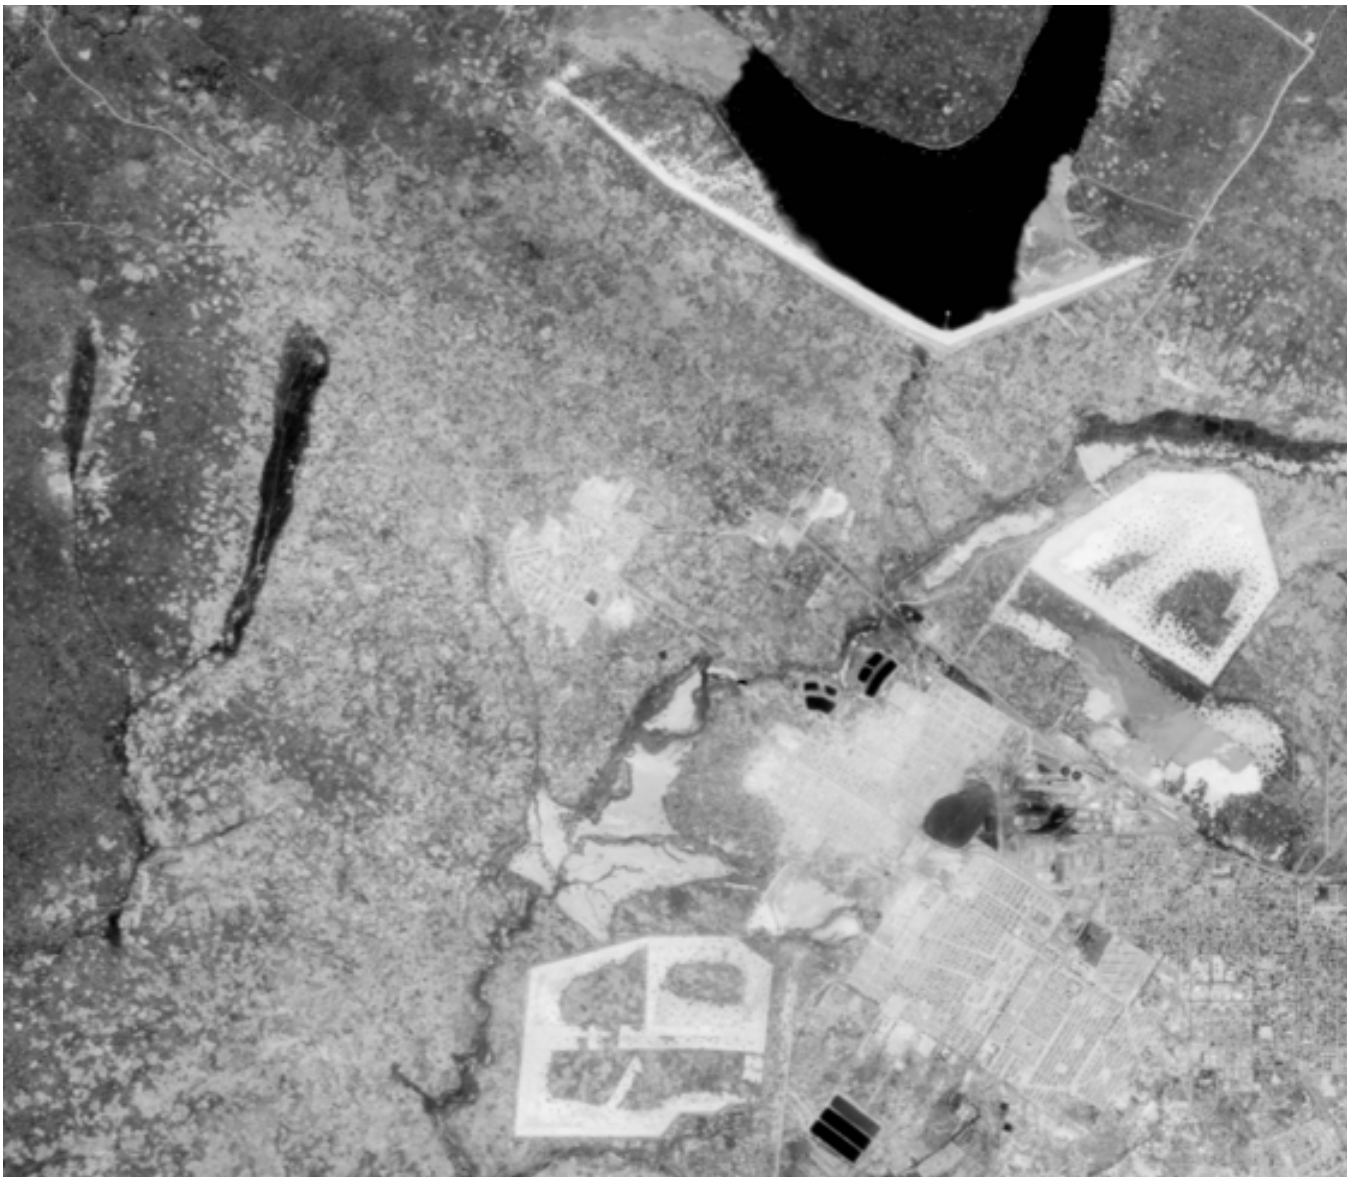
Figure 1. 1967 Greyscale satellite photo of the Mufulira Mine

Source [Fig 1]: Keyhole, September 22, 1967

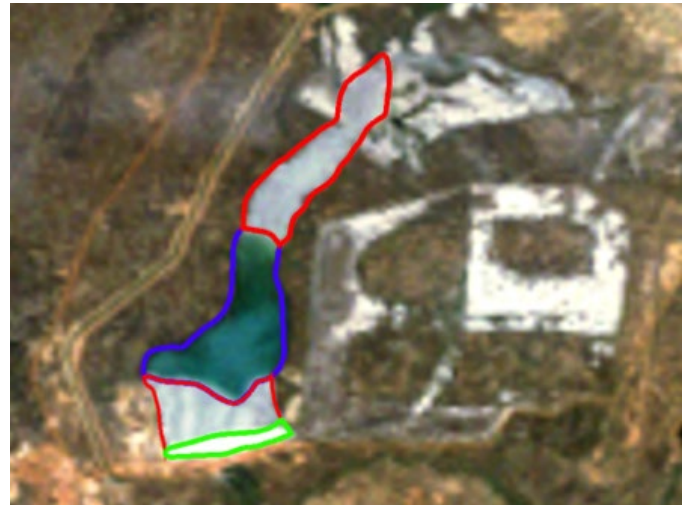
Figure 4a. 1989 Pond edges

Figure 4 shows the pond edges from the 1989 Landsat imagery overlaid on the 1967 original ground surface.

Source [Fig 4]: Keyhole, September 22, 1967 and Landsat 5, August 21, 1989

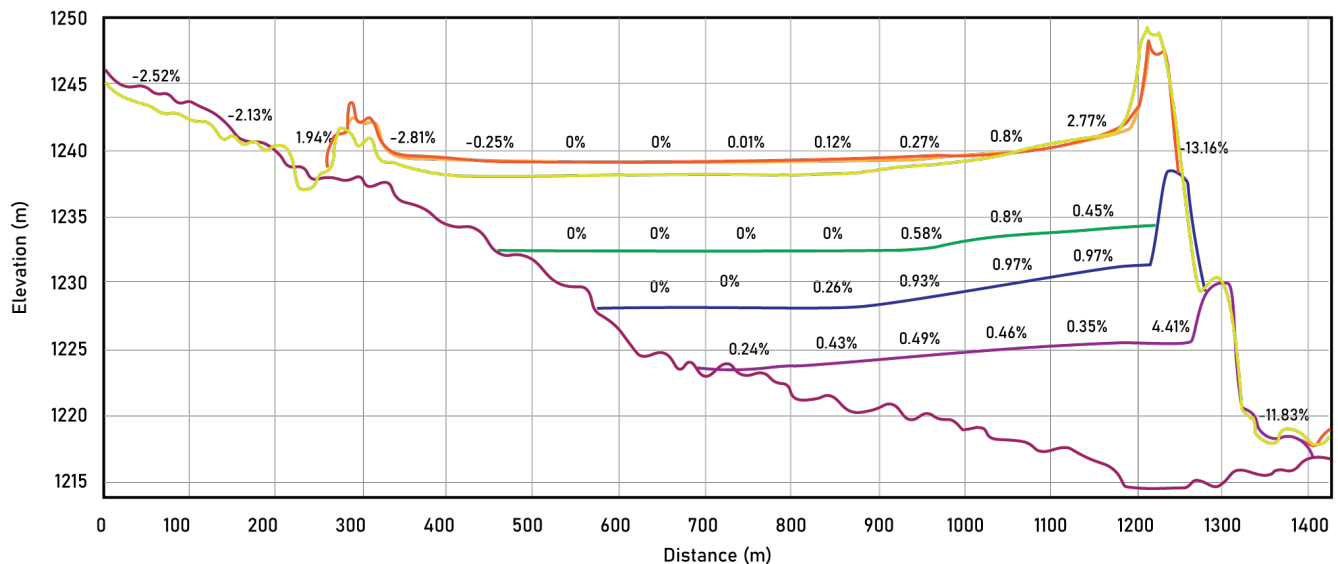
Figure 9. Tailings deposition by year

The stratigraphic cross-section (Fig 9) of the Mufulira TSF was created by compiling the individual surfaces from the WorldView 2010, 2017 and 2020 surveys and reconstructed surfaces from the earlier Keyhole and Landsat 5 satellite imagery.

- March 23, 2020
- July 13, 2017
- 2010 Crosstrack
- Aug 29, 1992
- Sep 25, 1990
- Aug 21, 1989
- 1967 Original Ground Surface

The cross-section at line B is shown in Figure 9.

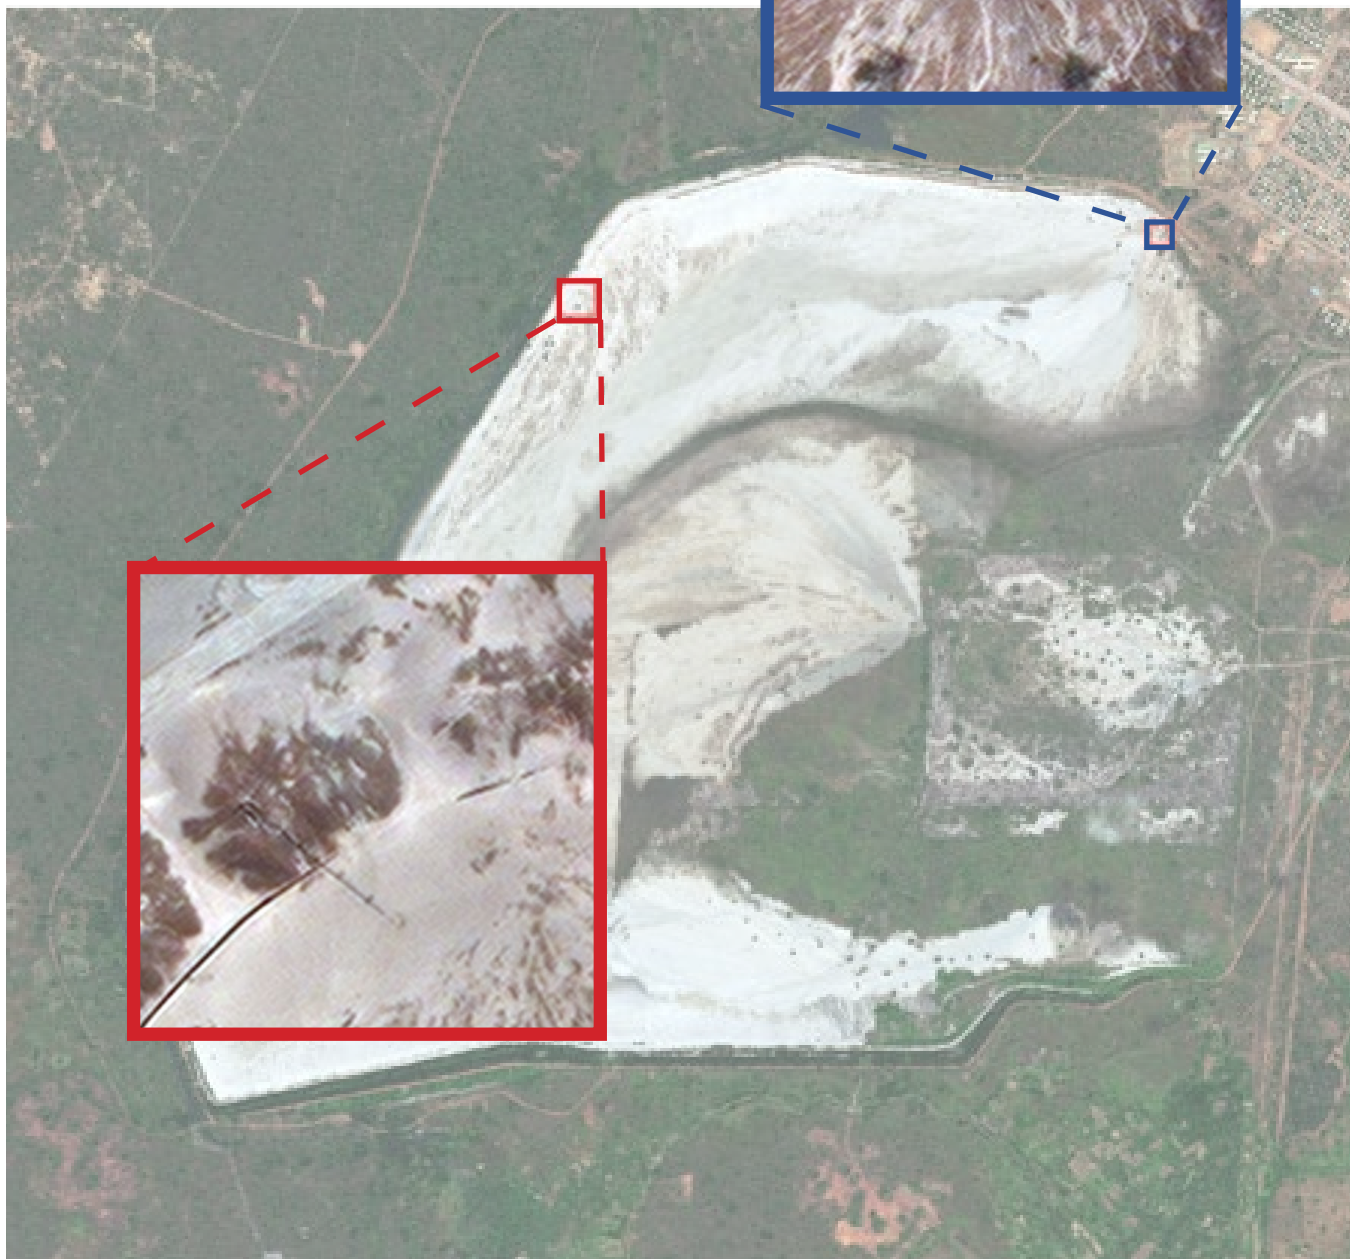
Figure 10. 2020 Fine and coarse tailings distribution

The distribution of coarse sands, fine sands and tailings deposited around the pond is shown below.

Source [Fig 10]: WV-3, March 23, 2020

The satellite imagery dated between 1989 and 2020 shows that the tailings pond did not extend closer than 200 m to the Mufulira TSF embankment. This indicates that this upstream TSF embankment most probably consists entirely of coarse sands.
