AbraPlata Diablillos Case History

Drill Hole Collar Verification
through a Comparison of
Survey Data Sets

Revised: January 7th, 2021

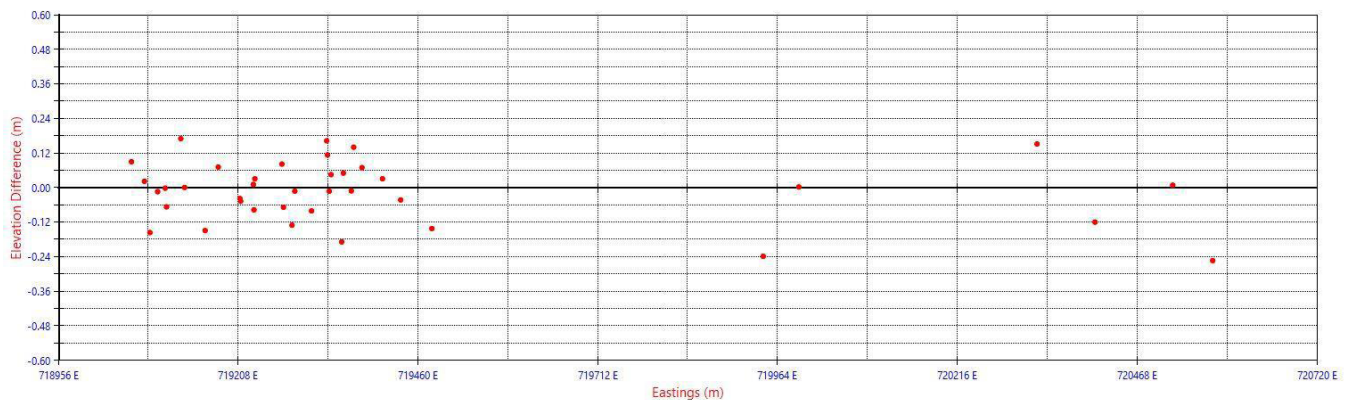
Figure 4: Vertical match between the 2017 drill collars and PhotoSat survey

The standard deviation of the difference between the PhotoSat survey grid and the elevations of the 38, 2017 drill holes is 10 cm.

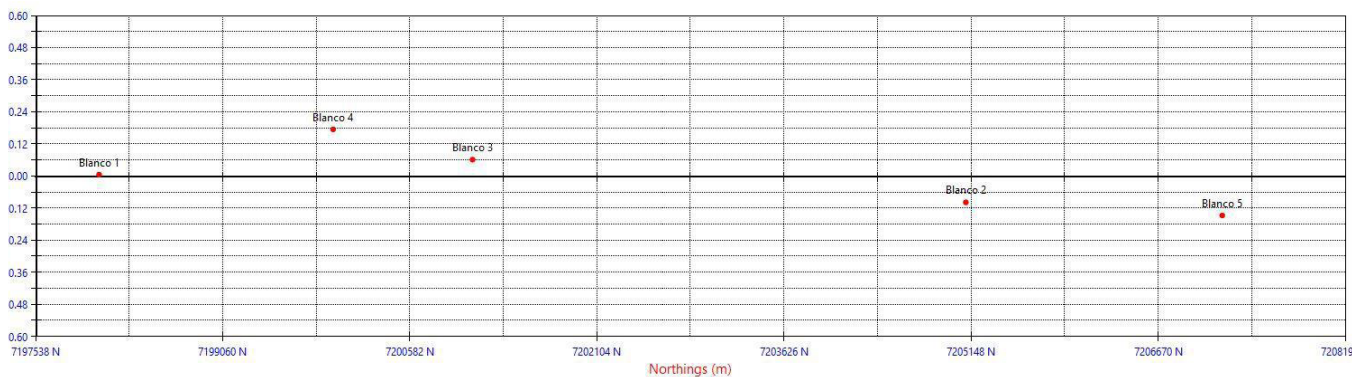
Figure 6: Vertical match between the ground reference points and PhotoSat survey

The PhotoSat survey was initially matched to these ground reference survey points. Then the elevations were adjusted downward 17 cm to match the elevations of the 2017 drill collars.

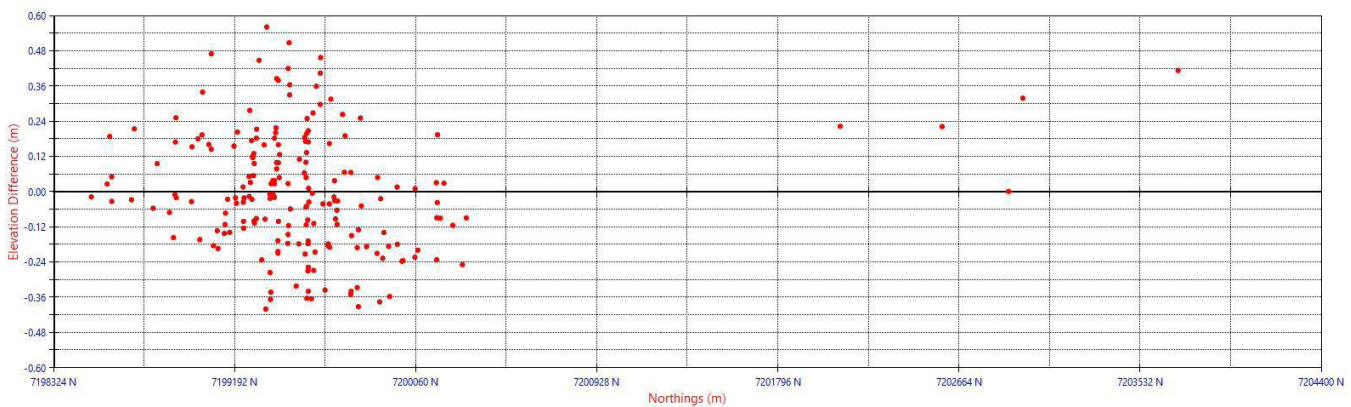
Figure 8: Vertical match between the 2006 drill collars and PhotoSat survey

The 206, 2006 drill collar elevations were adjusted 29 cm down to match the 2017 drill collar elevations. After this adjustment, 195 of the 2006 drill collar elevations match the PhotoSat survey elevations to a standard deviation of 20 cm.

The standard deviation of the difference between the PhotoSat survey grid and the elevations of 195 of the 2006 drill collars is 20 cm.
